# **DISTRICT INFRASTRUCTURE ASSESSMENT REPORT**

## **GREENEWAY IMPROVEMENT DISTRICT**

**APRIL 30, 2026**

**by:  
McINTOSH ASSOCIATES, an LJA COMPANY  
1950 SUMMIT PARK DRIVE  
ORLANDO, FL 32810**

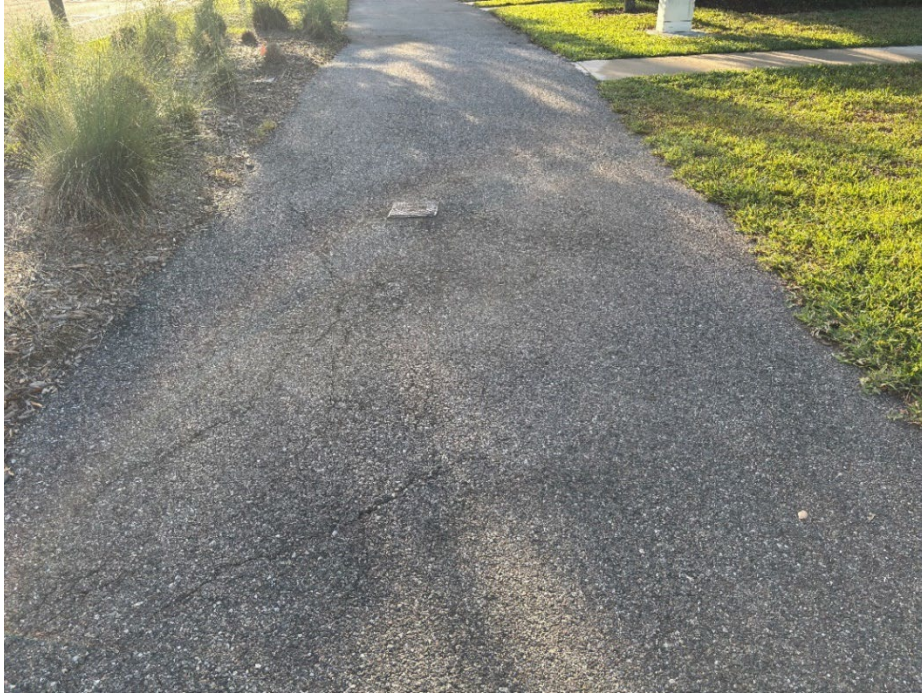
**Photo 1**  
**Asphalt Raveling (No Observed Changes)**  
**(Refer to Prior Photo 1 – 2025 Assessment)**

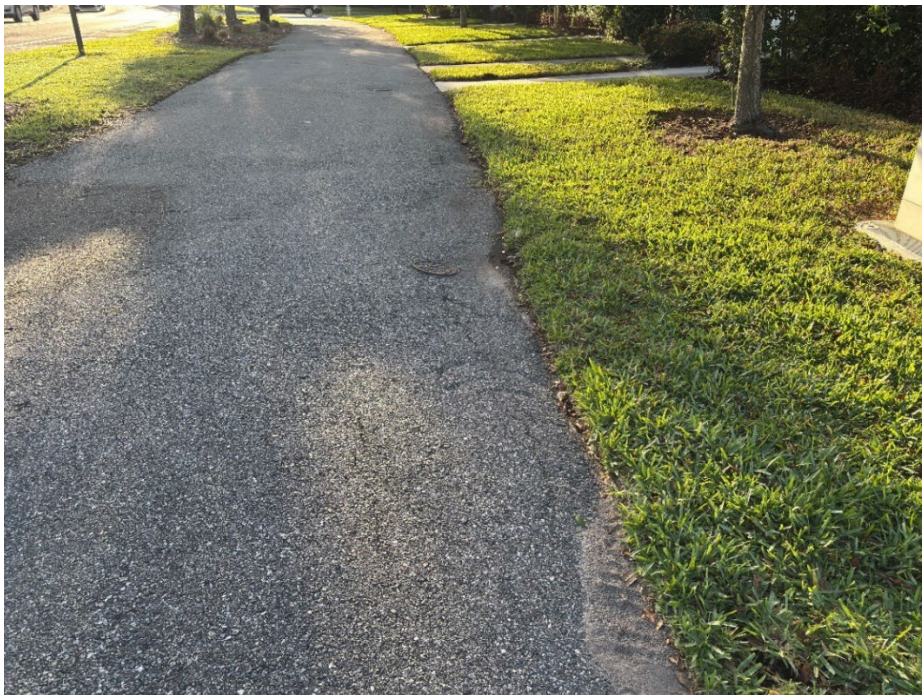
**Photo 2**  
**Asphalt Pavement Edge Failure (Increasing Edge Failure Observed)**  
**(Refer to Prior Photo 2 – 2025 Assessment)**

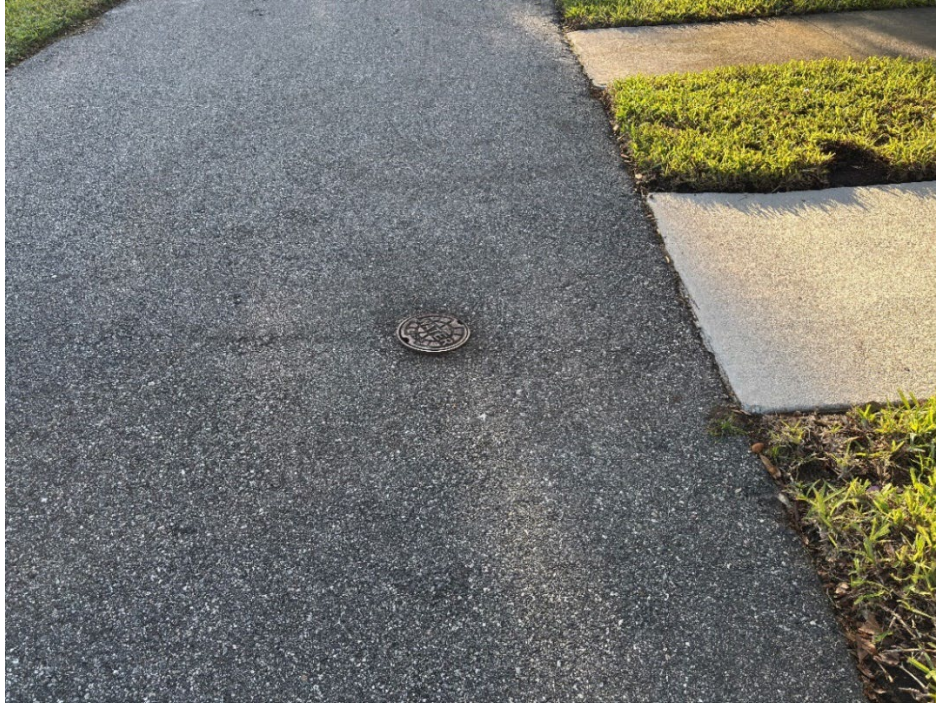
**Photo 3**  
**Valve Cover Approximately 1 inch Reveal (No Observed Changes)**  
**(Refer to Prior Photo 3 – 2025 Assessment)**

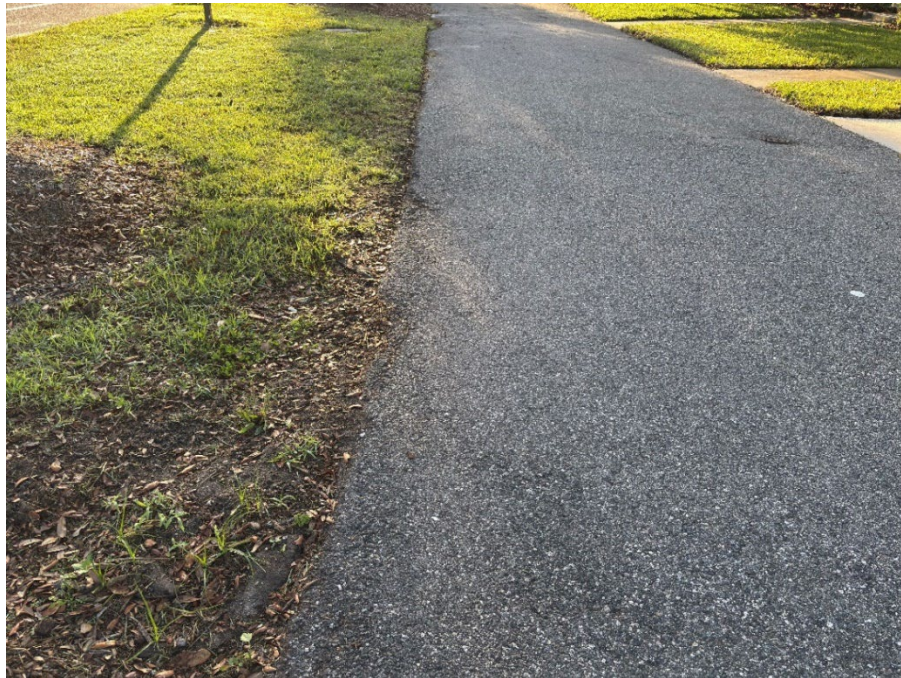
**Photo 4**  
**Asphalt Pavement Edge Failure (Increasing Edge Failure Observed)**  
**(Refer to Prior Photo 4 – 2025 Assessment)**

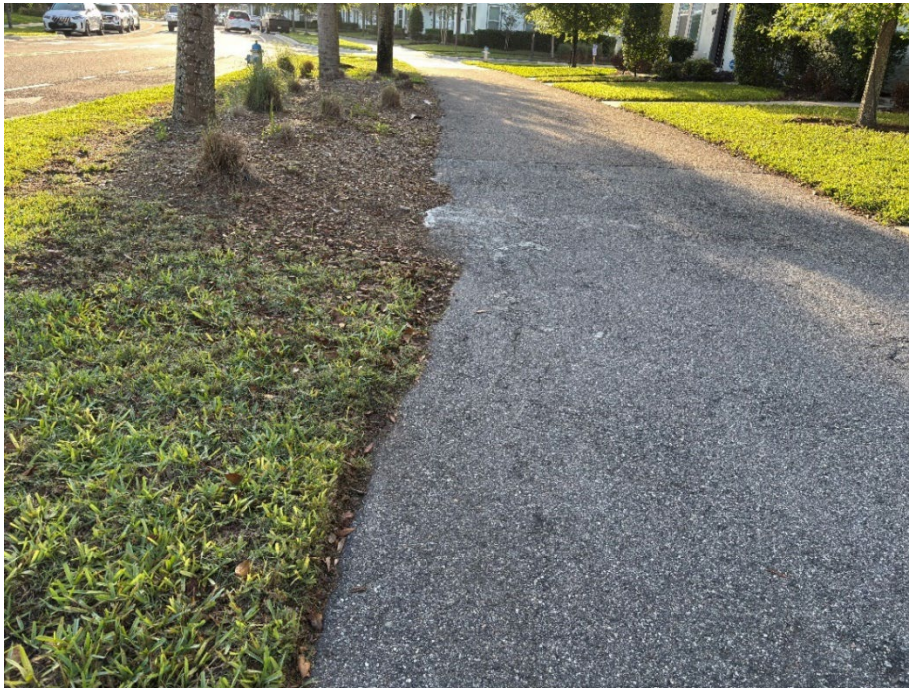
**Photo 5 - Asphalt Pavement Edge Failure (No Observed Changes)  
(Refer to Prior Photo 5 – 2025 Assessment)**

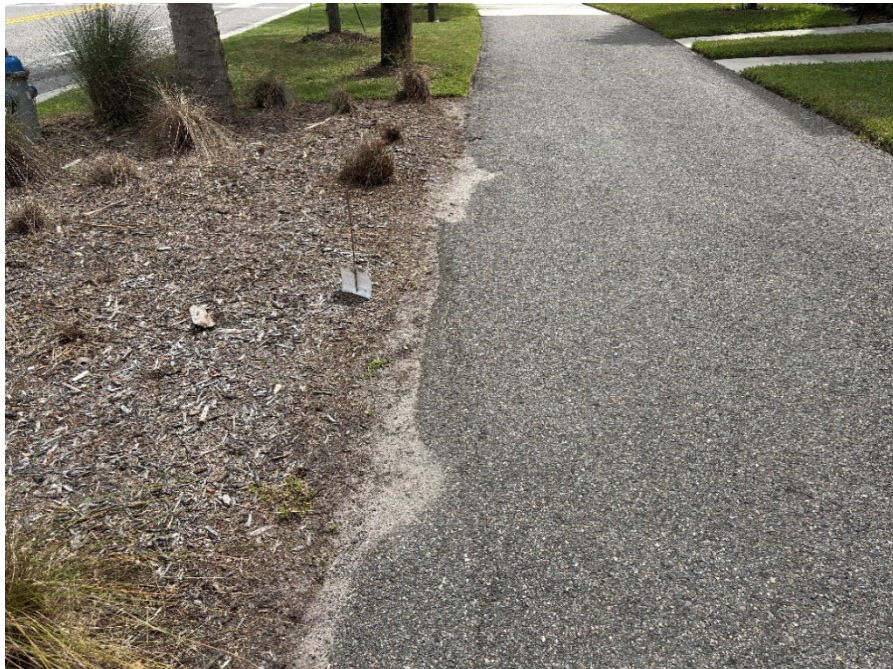
**Photo 6 - Asphalt Pavement Edge Failure (No Observed Changes)  
(Refer to Prior Photo 6 – 2025 Assessment)**

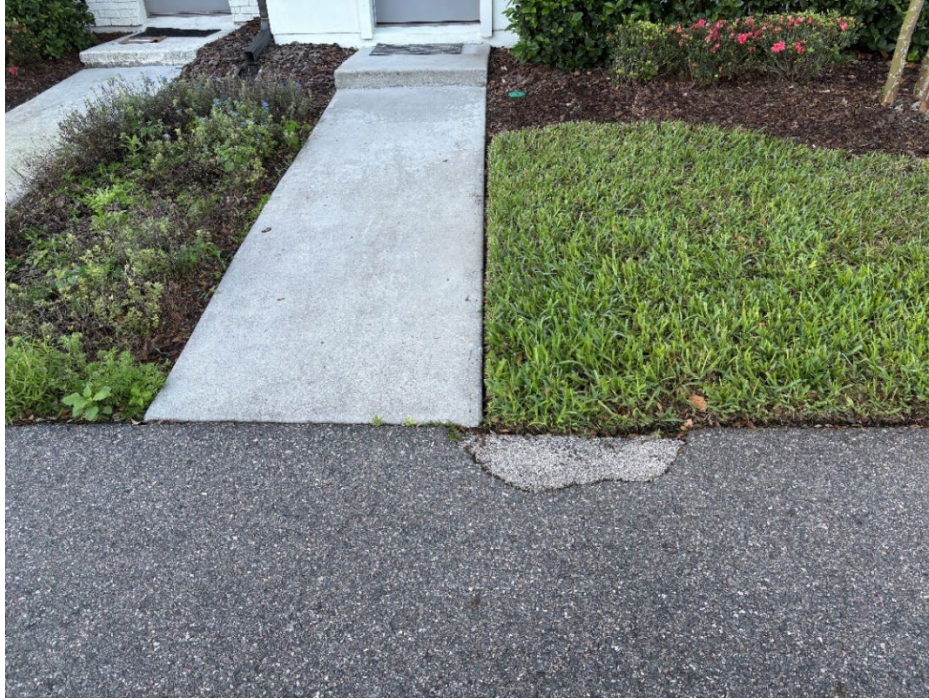
**Photo 7 - Poor Asphalt Patch (No Observed Changes)  
(Refer to Prior Photo 8 – 2025 Assessment)**

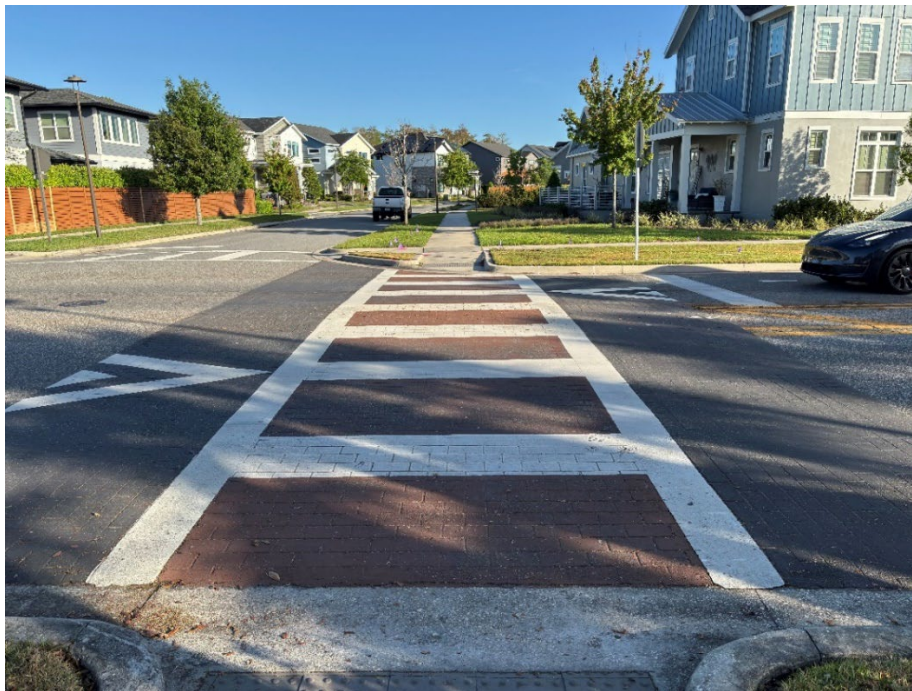
**Photo 8  
Deterioration of Thermoplastic and Worn Coloration (No Observed Changes)  
(Refer to Prior Photo 10 – 2025 Assessment)**

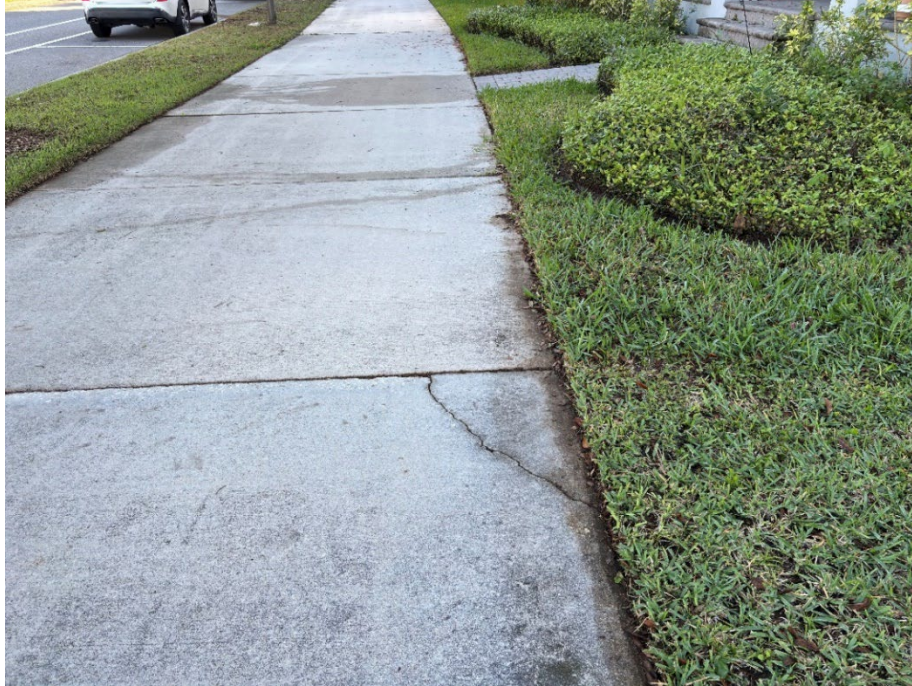
**Photo 8.1 - Cracked Concrete and Base Failure  
(New Photo – 2026 Assessment)**

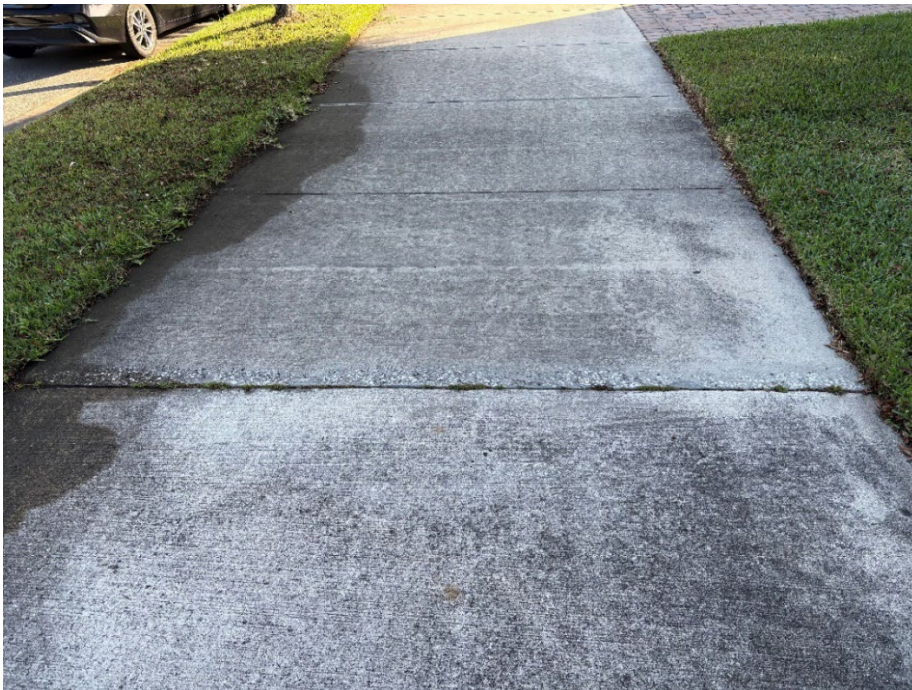
**Photo 9 – Concrete Slab Movement  
(Previously Ground Down - Additional Ponding Area Observed)  
(Refer to Prior Photo 11 – 2025 Assessment)**

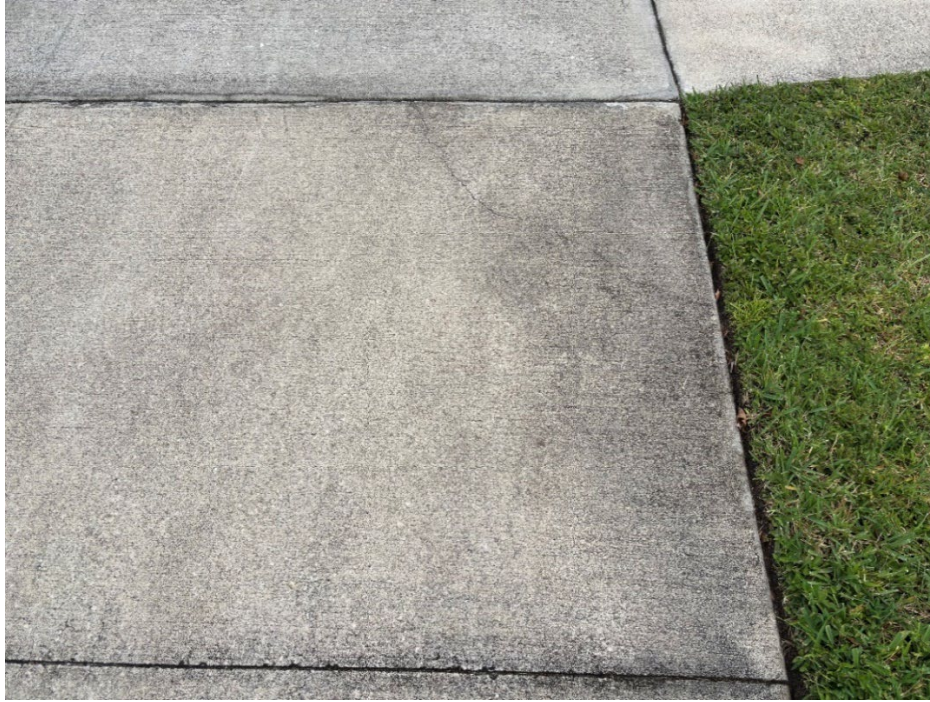
**Photo 10 - Cracked Concrete and Base Failure (No Observed Changes)  
(Refer to Prior Photo 14 – 2025 Assessment)**

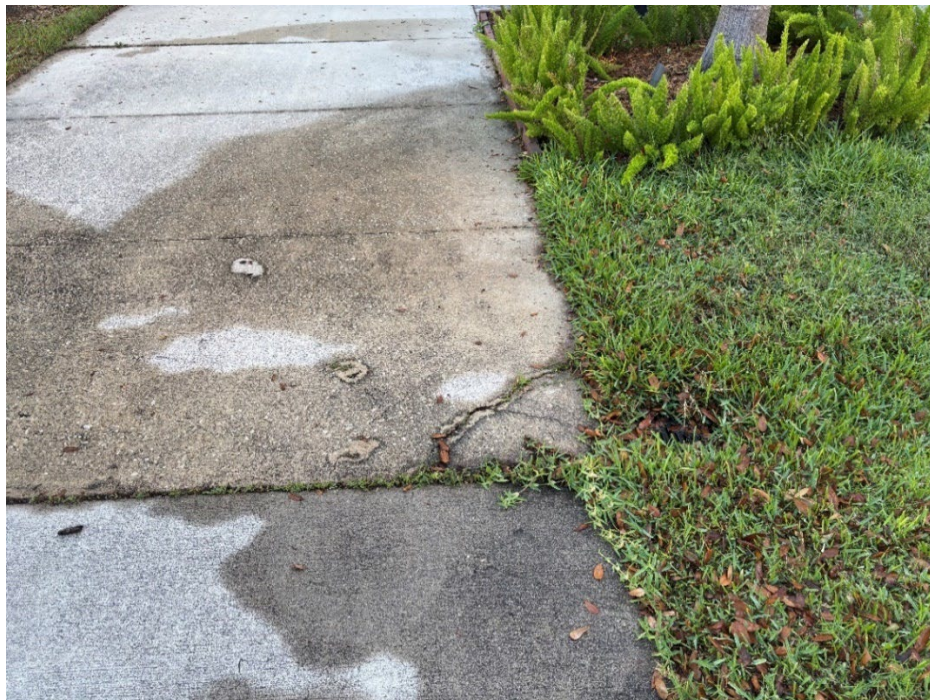
**Photo 11  
Cracked Concrete and Base Failure at Yard Drain (Base Failure Progressing)  
(Refer to Prior Photo 15 – 2025 Assessment)**

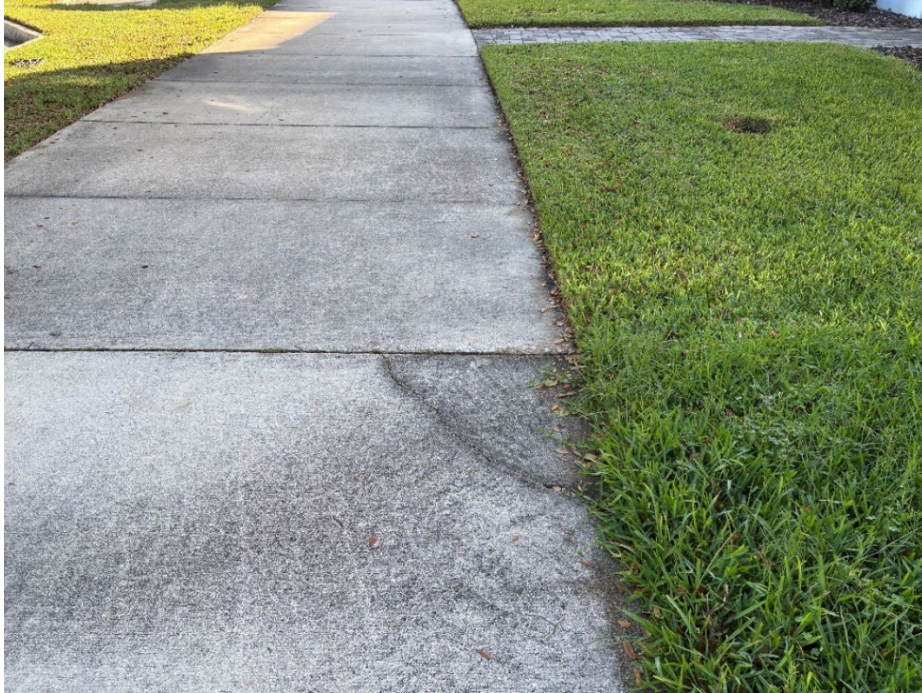
**Photo 12**  
**Cracked Concrete and Base Failure (No Observed Changes)**  
**(Refer to Prior Photo 16 – 2025 Assessment)**

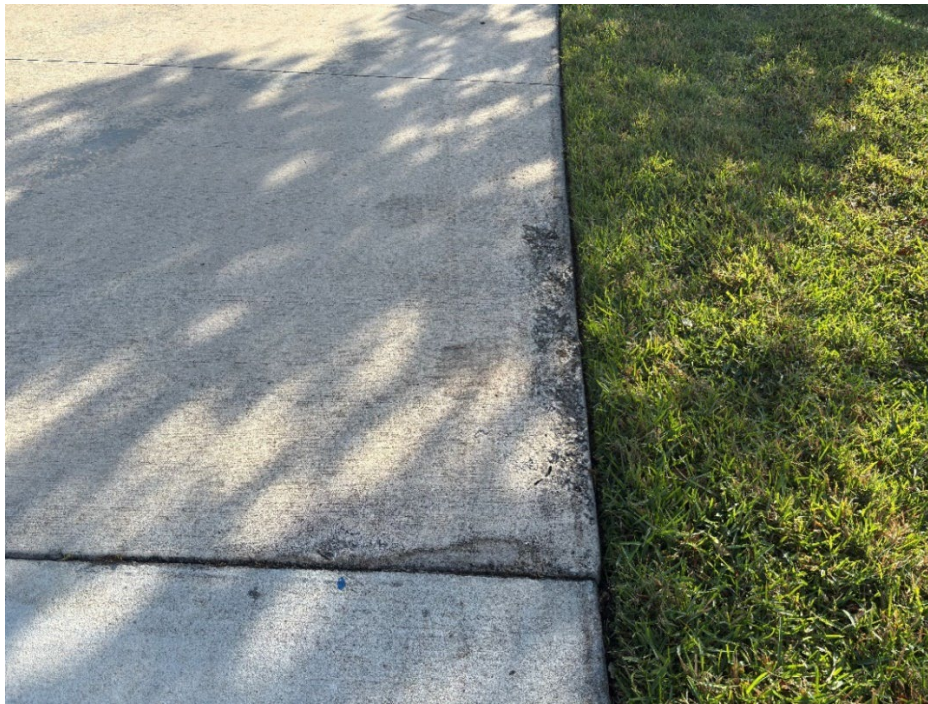
**Photo 12.1 – Failing Concrete Edging**  
**(New Photo – 2026 Assessment)**

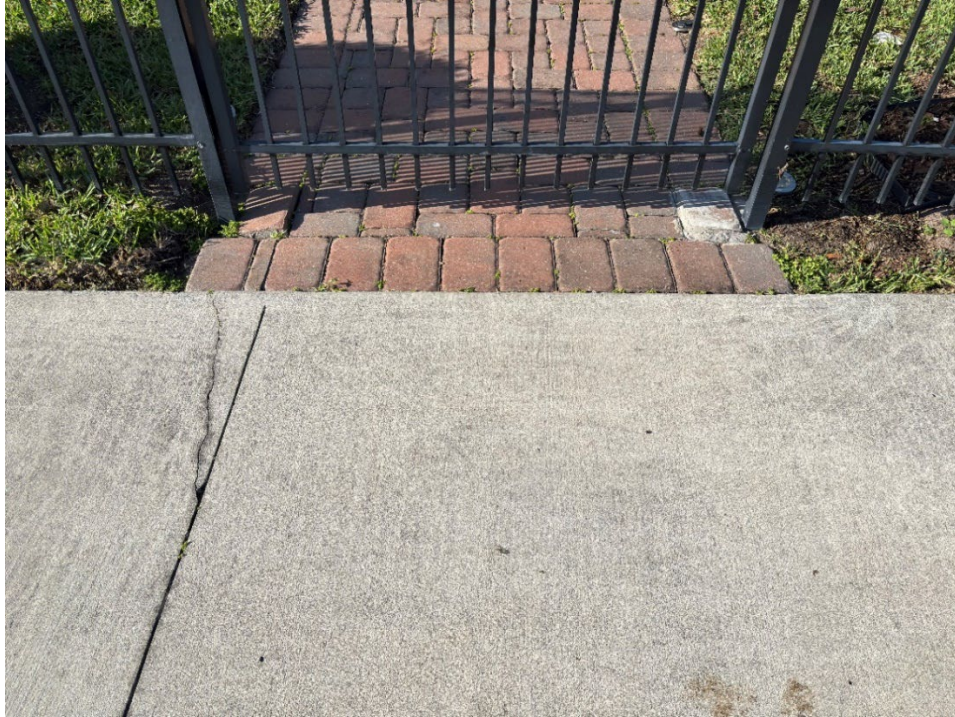
**Photo 13 - Surficial Cracked Concrete (No Observed Changes)  
(Refer to Prior Photo 17 – 2025 Assessment)**

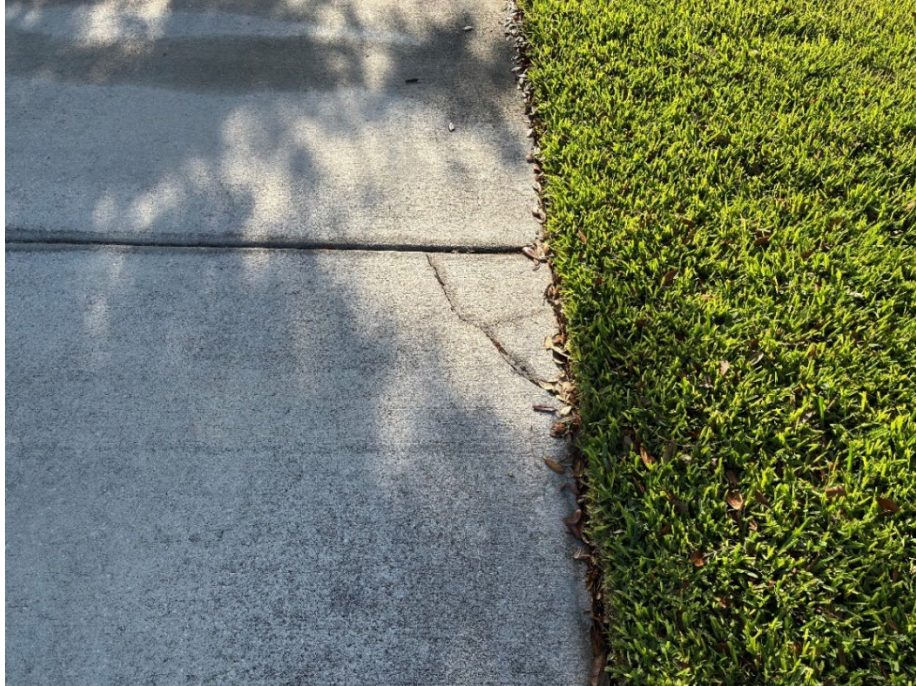
**Photo 14 - Cracked Concrete and Base Failure (No Observed Changes)  
(Refer to Prior Photo 18 – 2025 Assessment)**

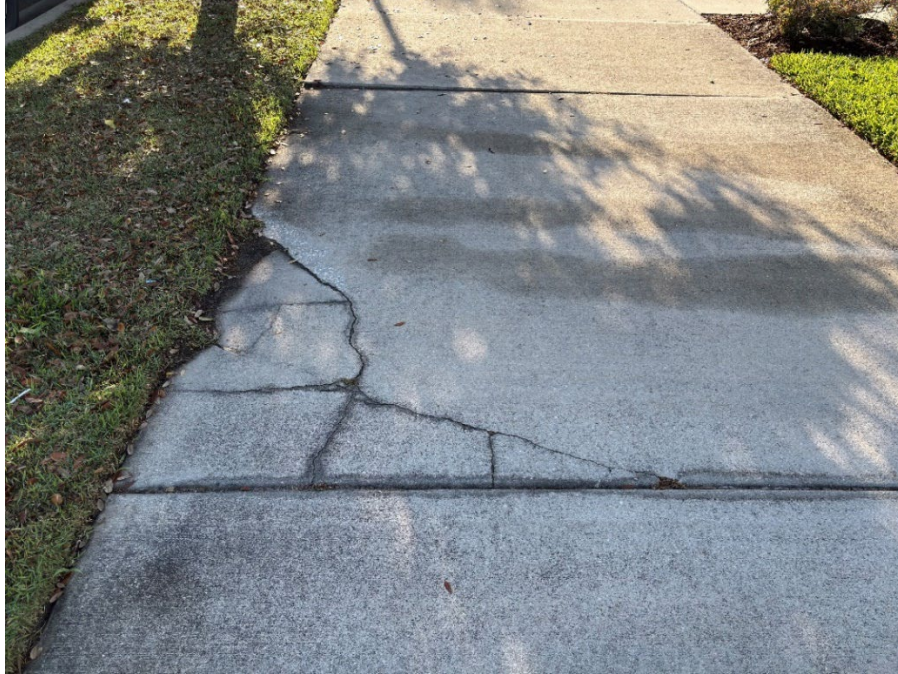
**Photo 15 - Cracked Concrete and Base Failure (No Observed Changes)  
(Refer to Prior Photo 19 – 2025 Assessment)**

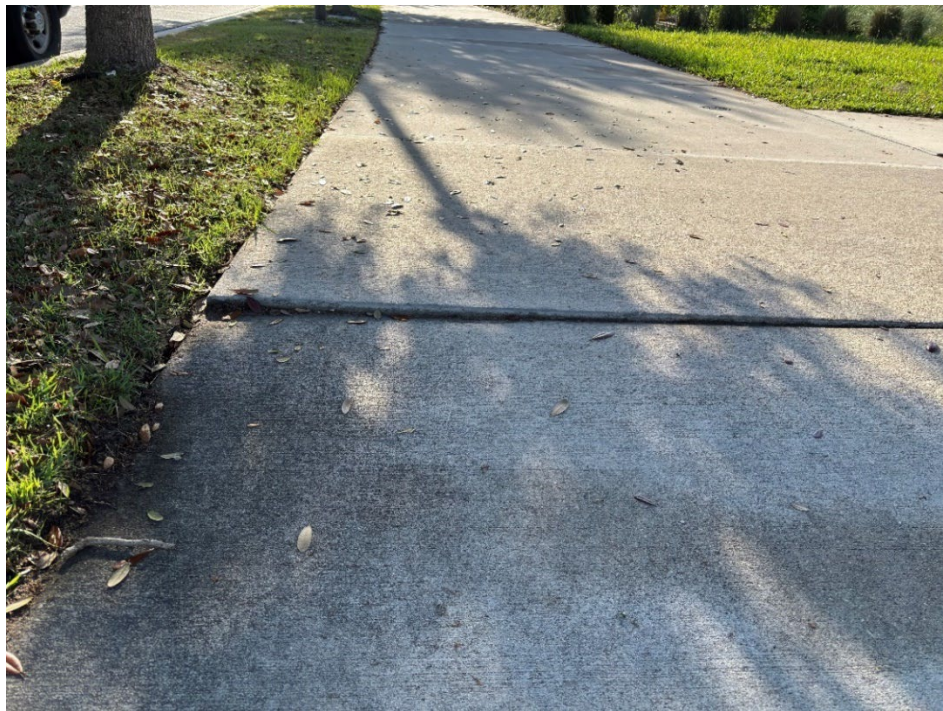
**Photo 15.1 – Concrete Slab Movement  
(New Photo – 2026 Assessment)**

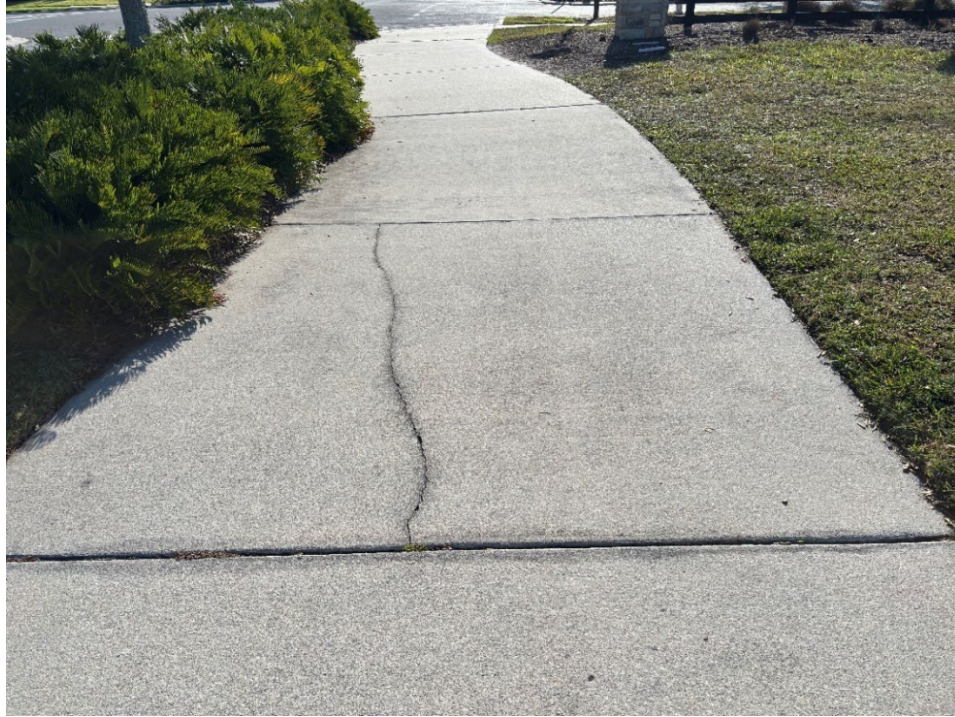
**Photo 16 - Cracked Concrete (No Observed Changes)  
(Refer to Prior Photo 21 – 2025 Assessment)**

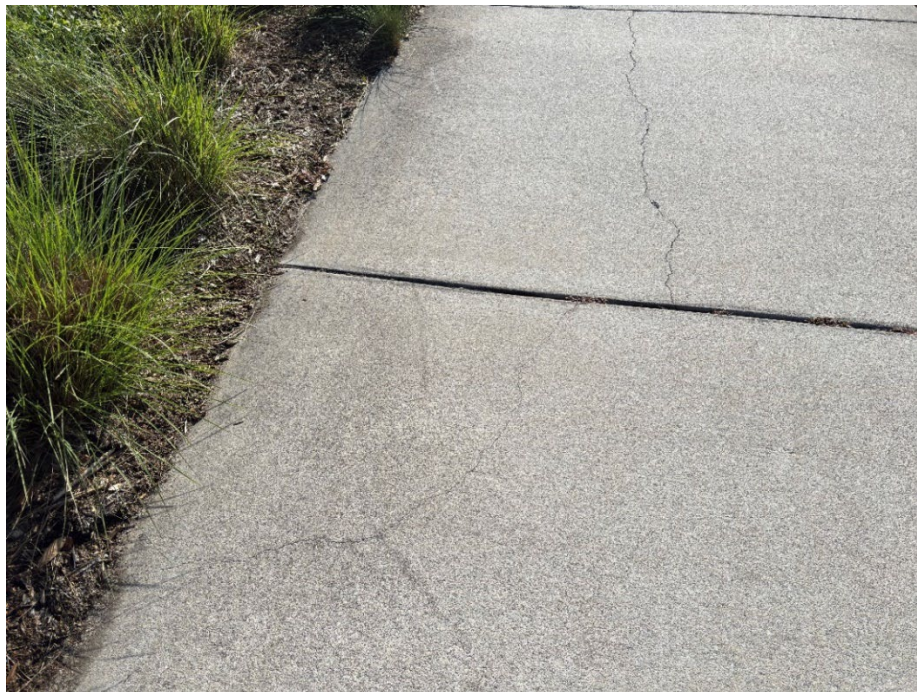
**Photo 17 - Surficial Cracked Concrete (No Observed Changes)  
(Refer to Prior Photo 22 – 2025 Assessment)**

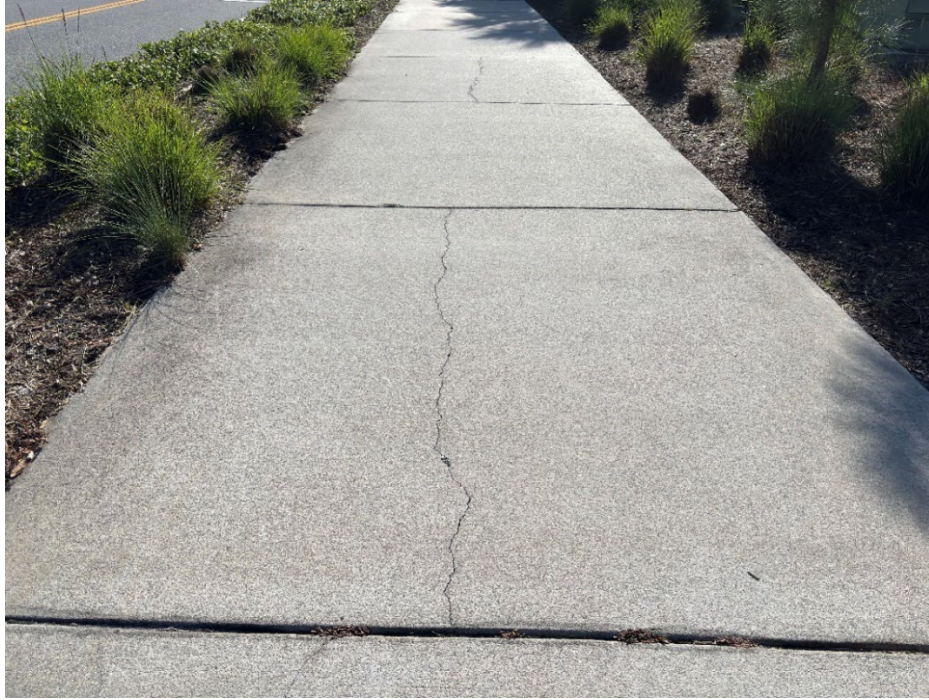
**Photo 18 - Surficial Cracked Concrete (No Observed Changes)  
(Refer to Prior Photo 23 – 2025 Assessment)**

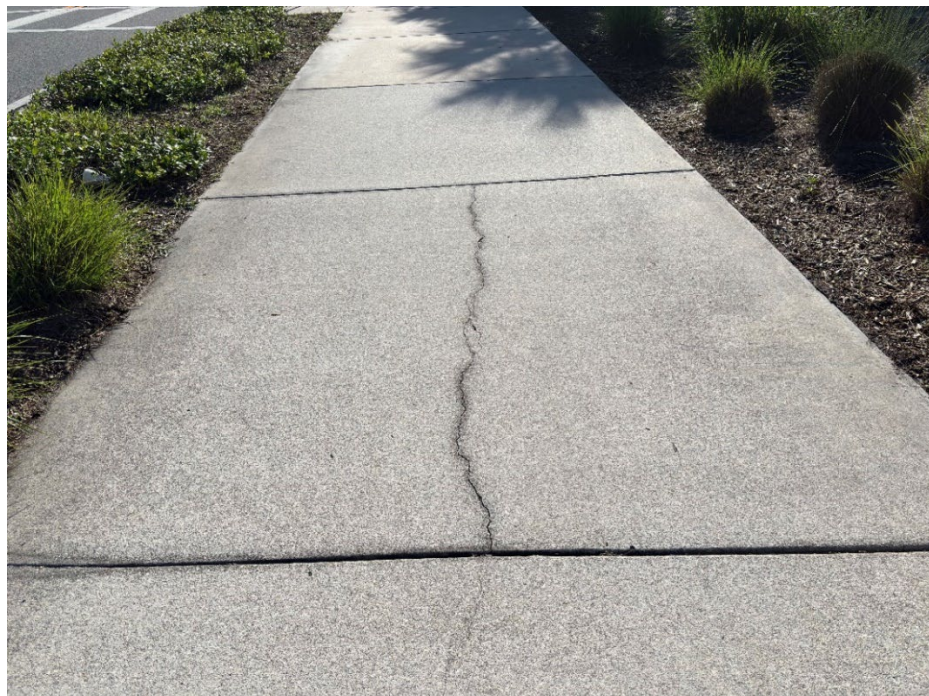
**Photo 19 - Cracked Concrete (No Observed Changes)  
(Refer to Prior Photo 24 – 2025 Assessment)**

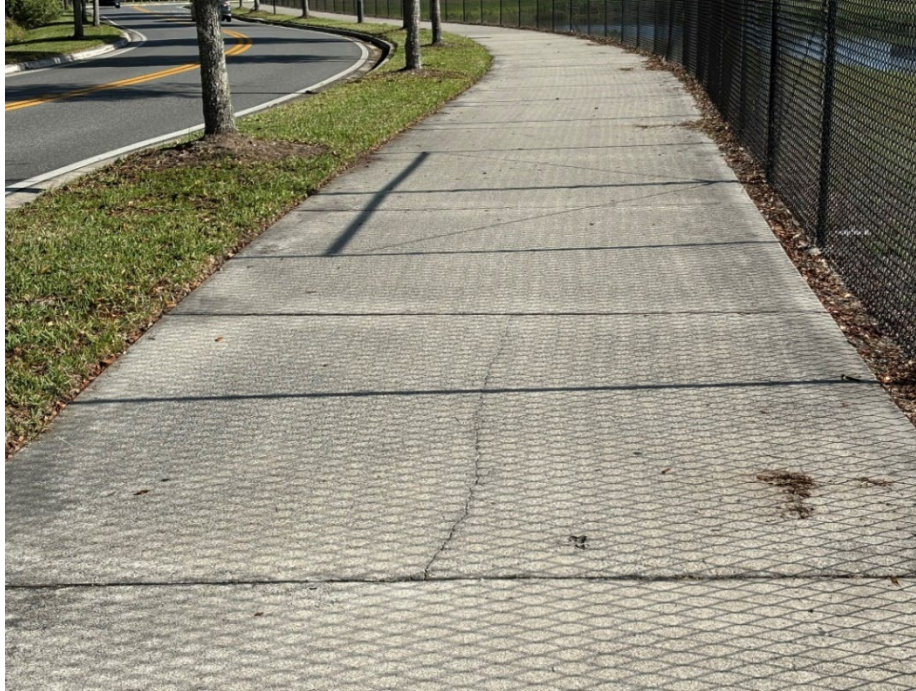
**Photo 20 - Surficial Cracked Concrete (No Observed Changes)  
(Refer to Prior Photo 27 – 2025 Assessment)**

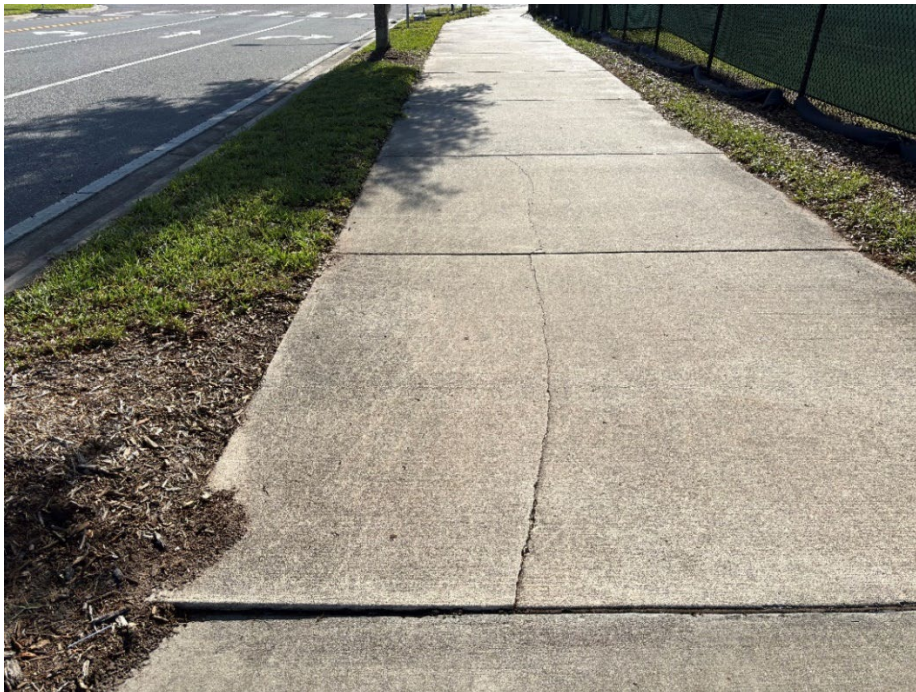
**Photo 20.1 - Cracked Concrete (Additional Slab Movement Observed)  
(New Photo – 2026 Assessment)**

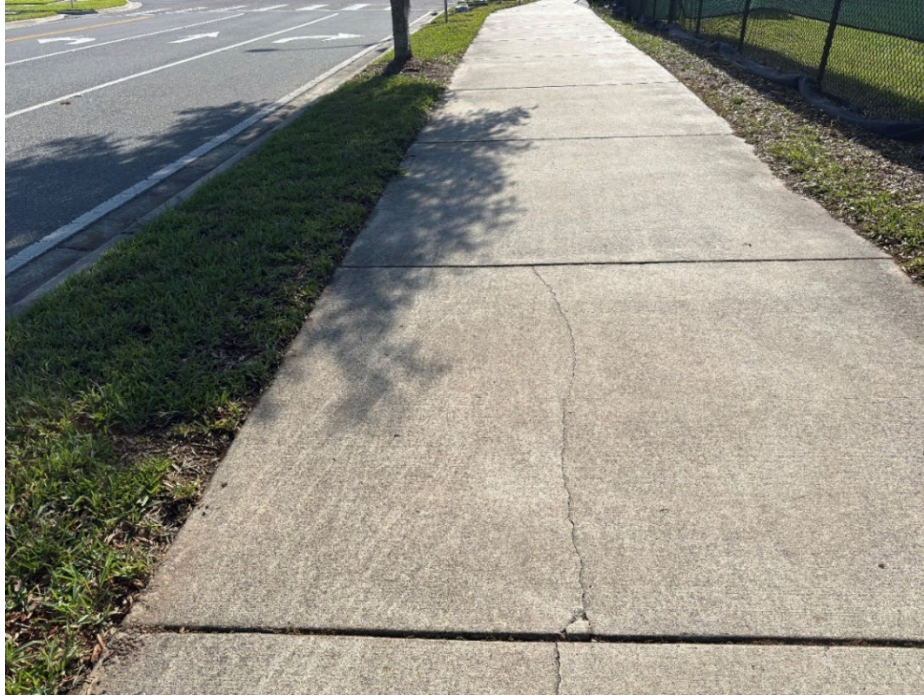
**Photo 21 - Surficial Cracked Concrete (No Observed Changes)  
(Refer to Prior Photo 29 – 2025 Assessment)**

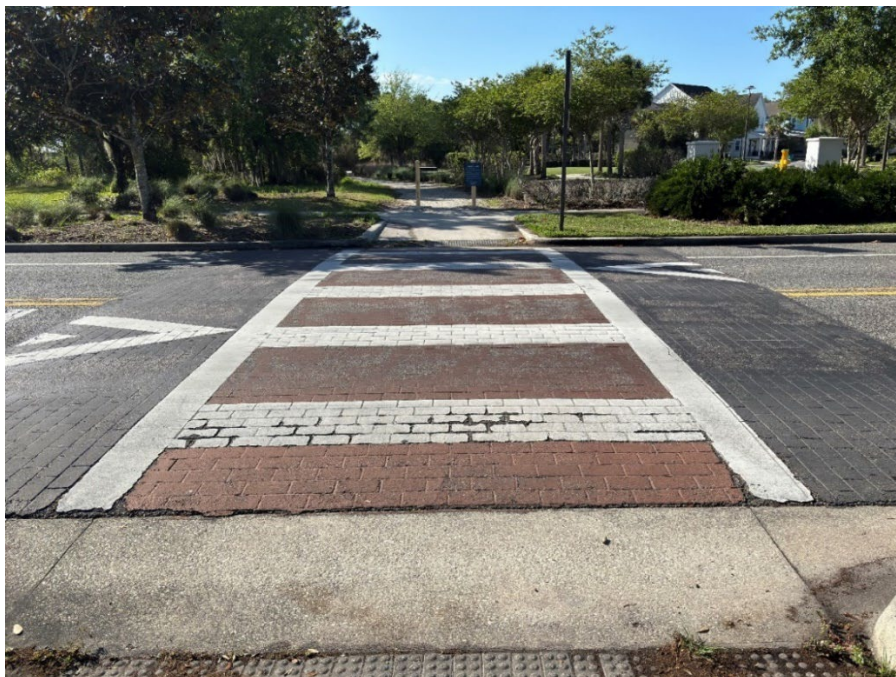
**Photo 22 - Deteriorating Thermoplastic and Worn Crosswalk Coloration  
(Further Deterioration Observed)  
(Refer to Prior Photo 30 – 2025 Assessment)**

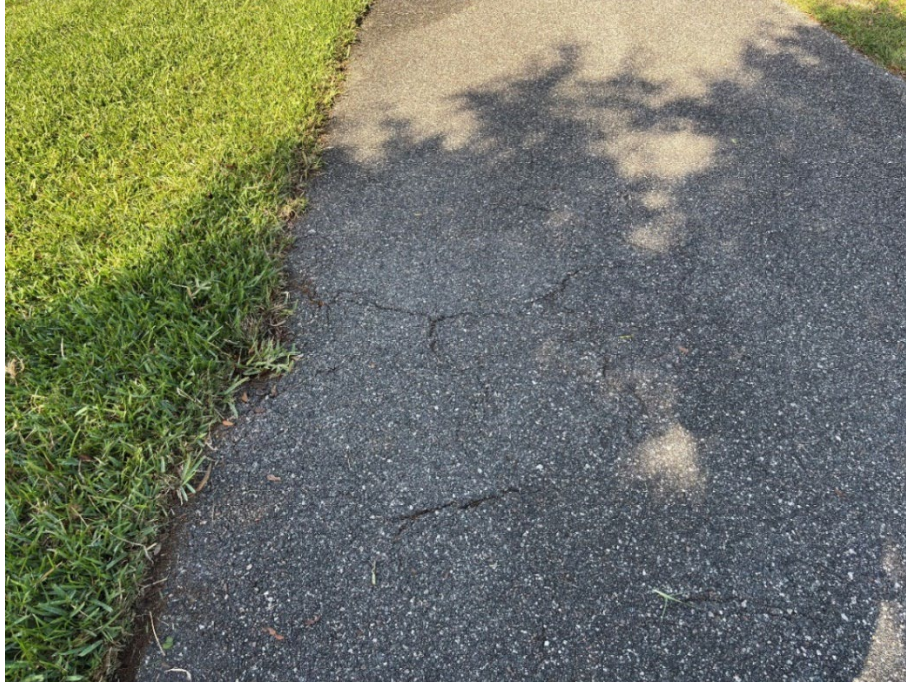
**Photo 23**  
**Asphalt Raveling and Base Failure (No Observed Changes)**  
**(Refer to Prior Photo 31 – 2025 Assessment)**

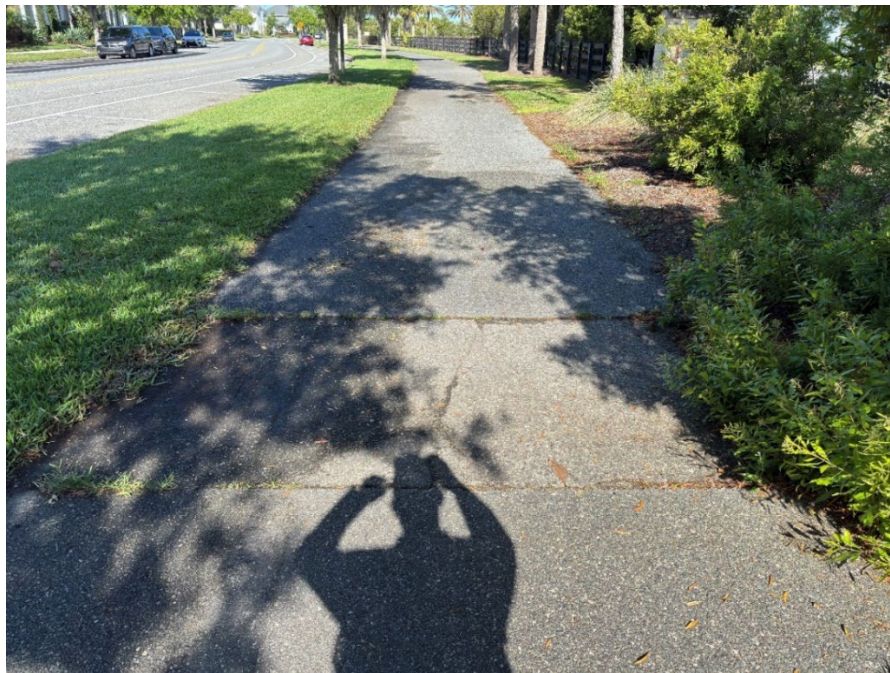
**Photo 24**  
**Poor Quality Asphalt Patch (Asphalt Patch Edge Failure Observed)**  
**(Refer to Prior Photo 33 – 2025 Assessment)**

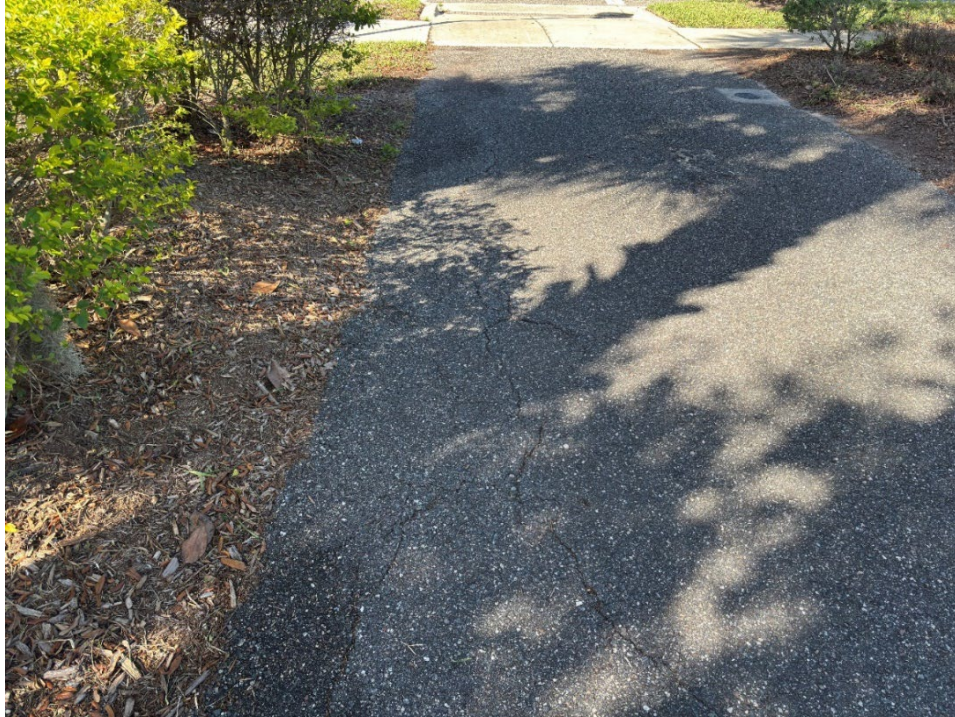
**Photo 25 - Asphalt Raveling (No Observed Changes)  
(Refer to Prior Photo 34 – 2025 Assessment)**

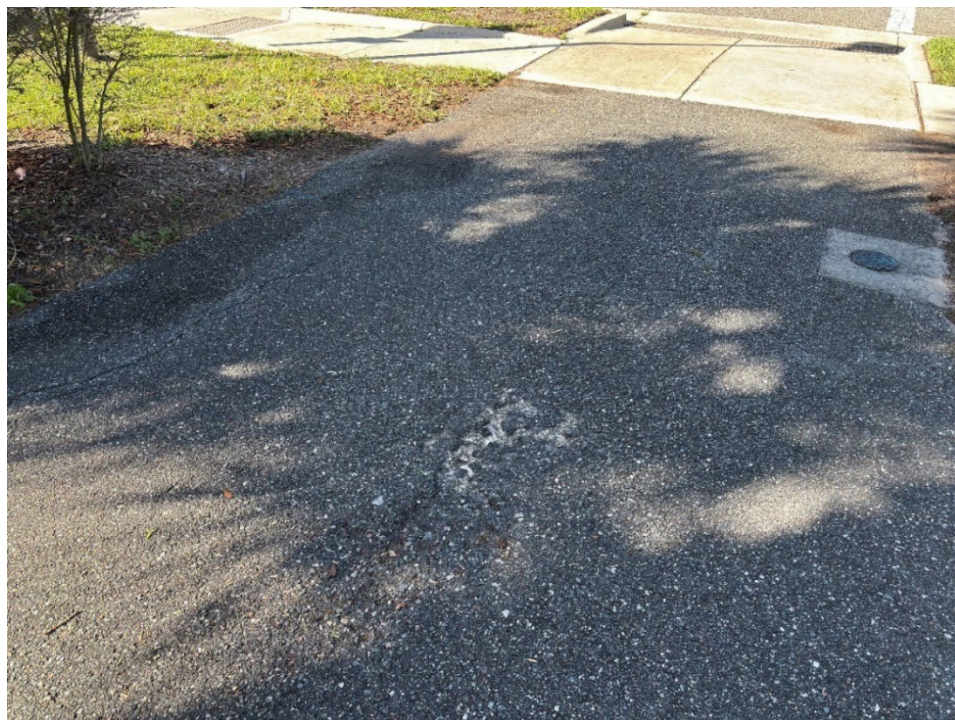
**Photo 25.1 – Asphalt Damage  
(New Photo – 2026 Assessment)**

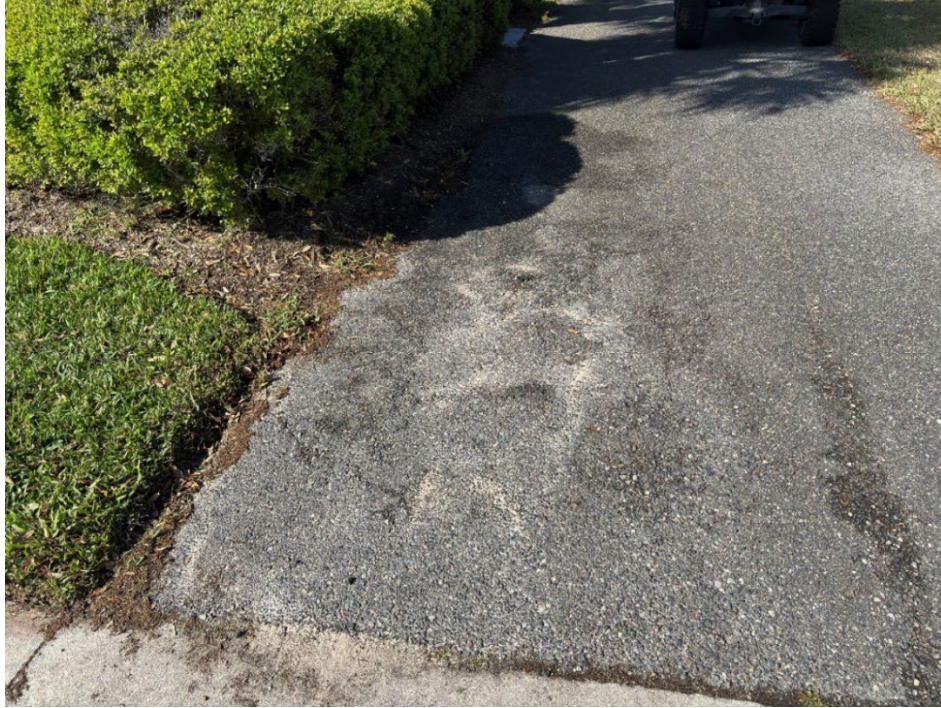
**Photo 25.2 – Asphalt Raveling and Base Failure  
(New Photo – 2026 Assessment)**

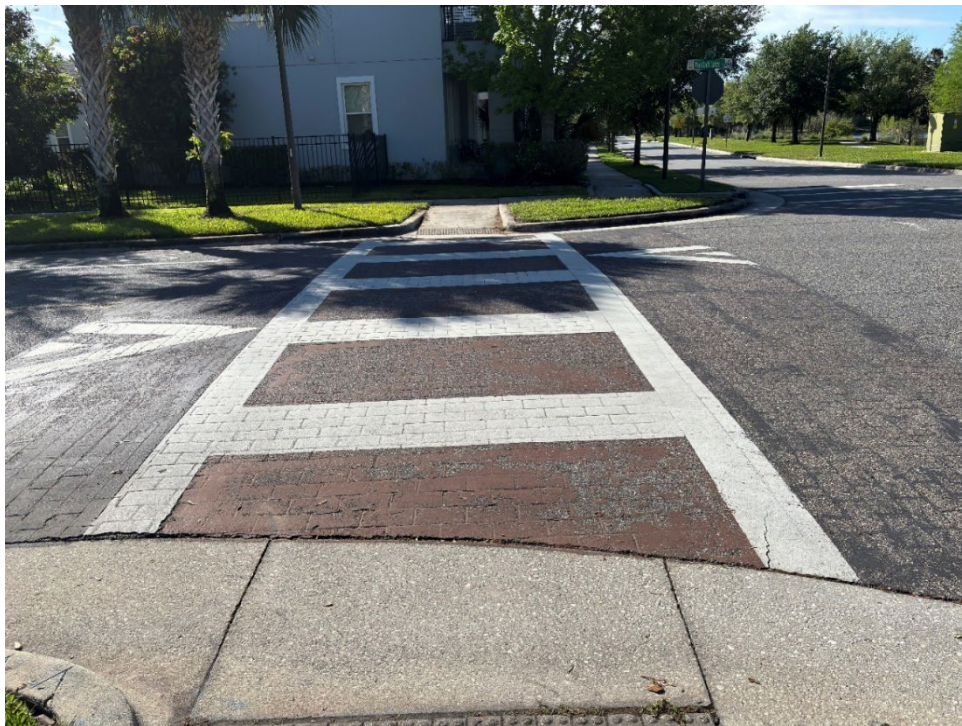
**Photo 26  
Deteriorating Thermoplastic and Worn Crosswalk Coloration (No Observed Changes)  
(Refer to Prior Photo 35 – 2025 Assessment)**

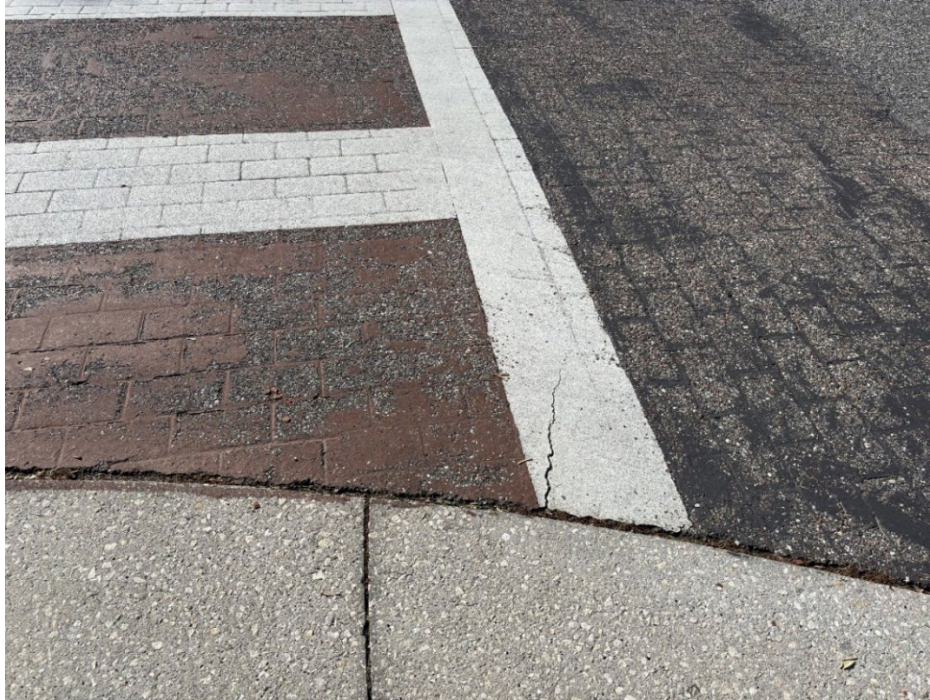
**Photo 27**  
**Deteriorating Thermoplastic and Worn Crosswalk Coloration (No Observed Changes)**  
**(Refer to Prior Photo 36 – 2025 Assessment)**

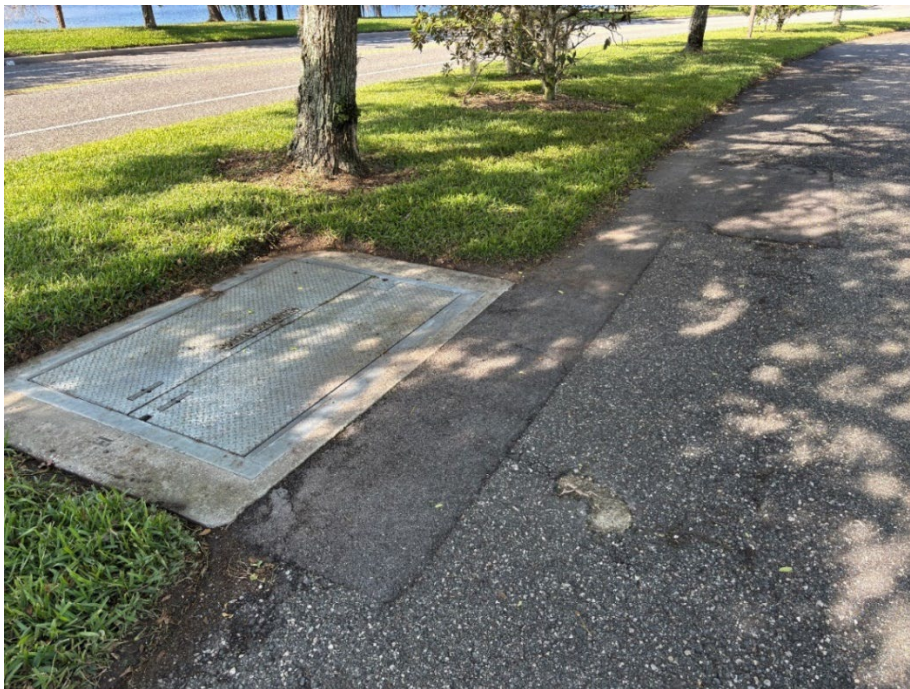
**Photo 28**  
**Poor Quality Asphalt Patch (No Observed Changes)**  
**(Refer to Prior Photo 37 – 2025 Assessment)**
