# **DISTRICT INFRASTRUCTURE ASSESSMENT REPORT**

## **GREENEWAY IMPROVEMENT DISTRICT**

**APRIL 30, 2026**

**by:  
McINTOSH ASSOCIATES, an LJA COMPANY  
1950 SUMMIT PARK DRIVE  
ORLANDO, FL 32810**

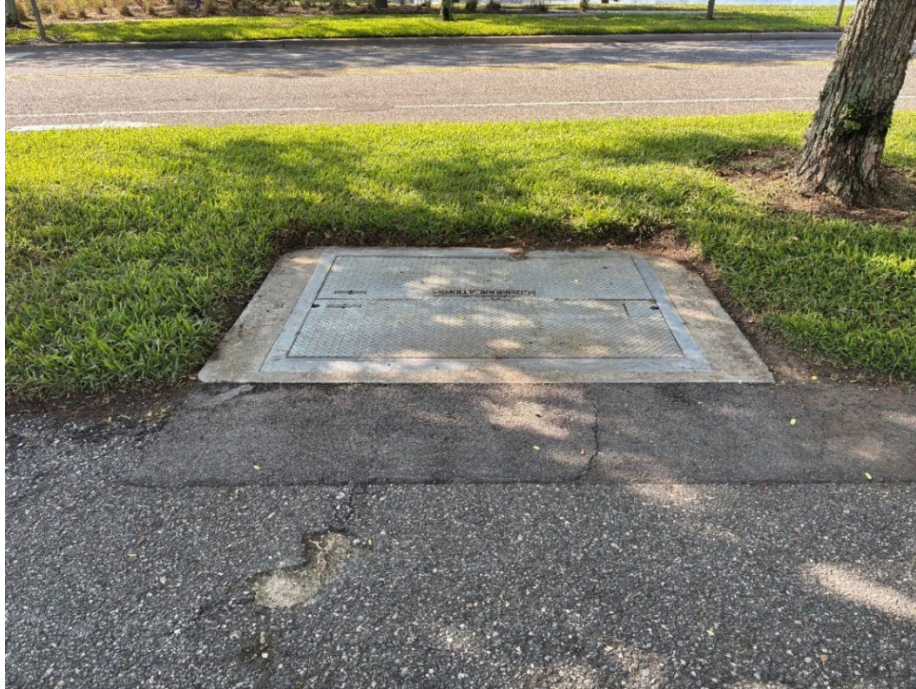
**Photo 29 - Poor Quality Asphalt Patch (No Observed Changes)  
(Refer to Prior Photo 38 – 2025 Assessment)**

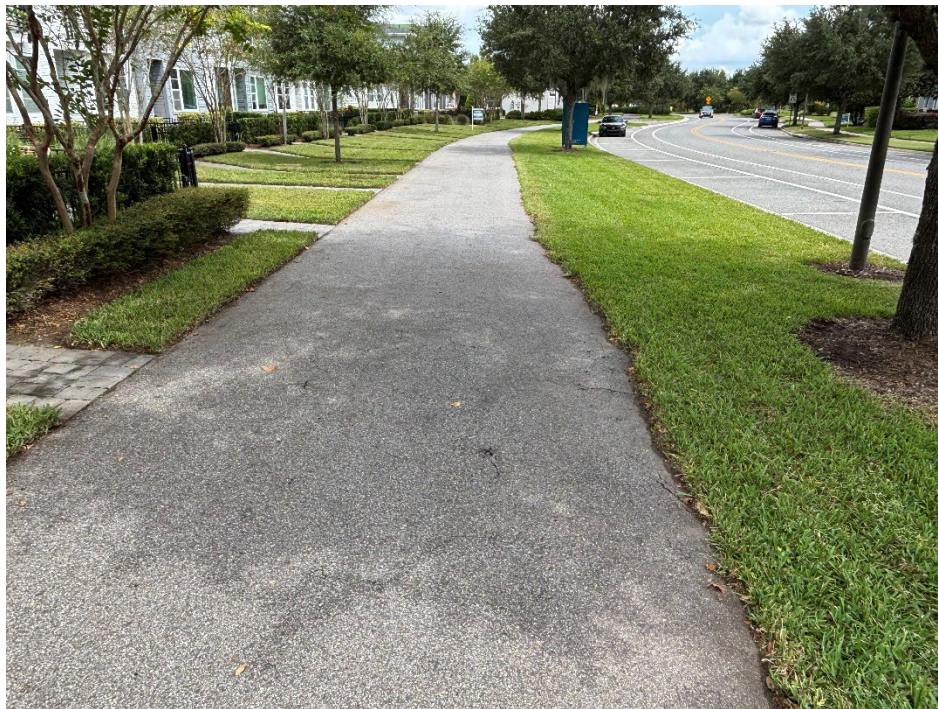
**Photo 30 - Asphalt Edge Failure (No Observed Changes)  
(Refer to Prior Photo 39 – 2025 Assessment)**

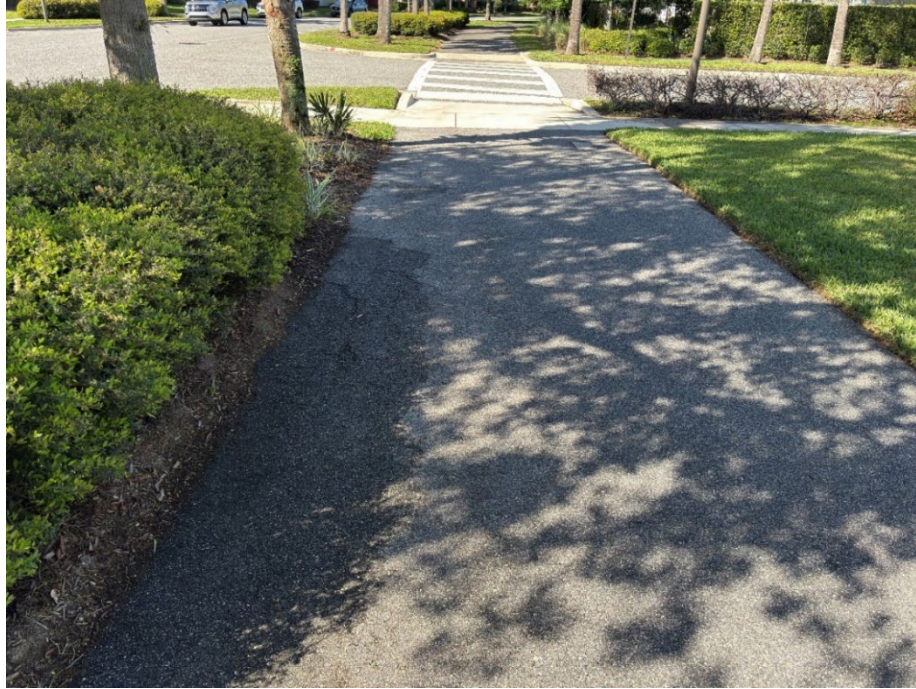
**Photo 31 - Asphalt Raveling (No Observed Changes)  
(Refer to Prior Photo 40 – 2025 Assessment)**

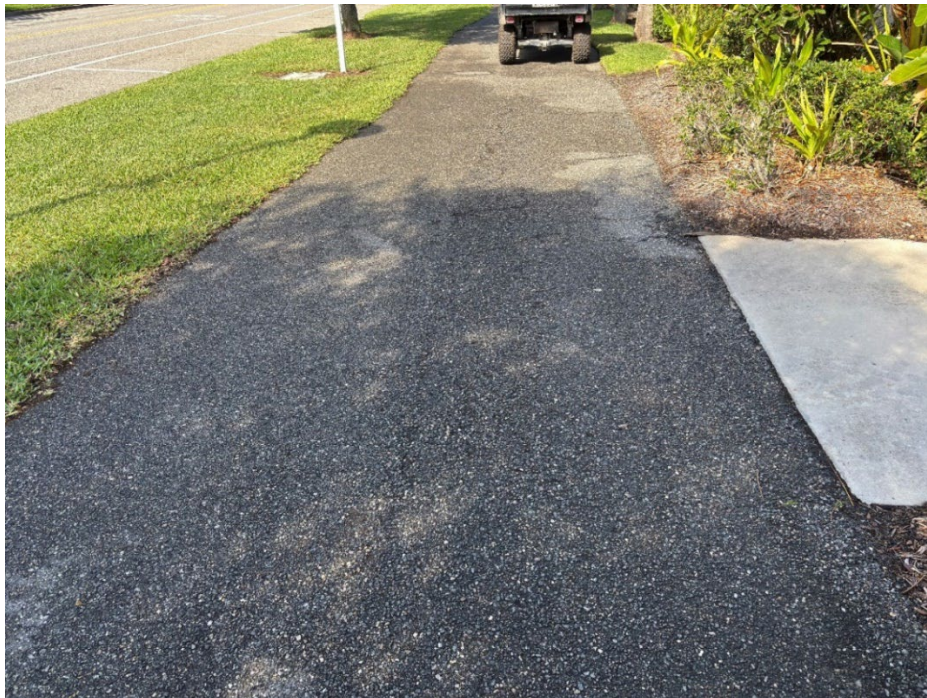
**Photo 32 - Asphalt Raveling (No Observed Changes)  
(Refer to Prior Photo 42 – 2025 Assessment)**

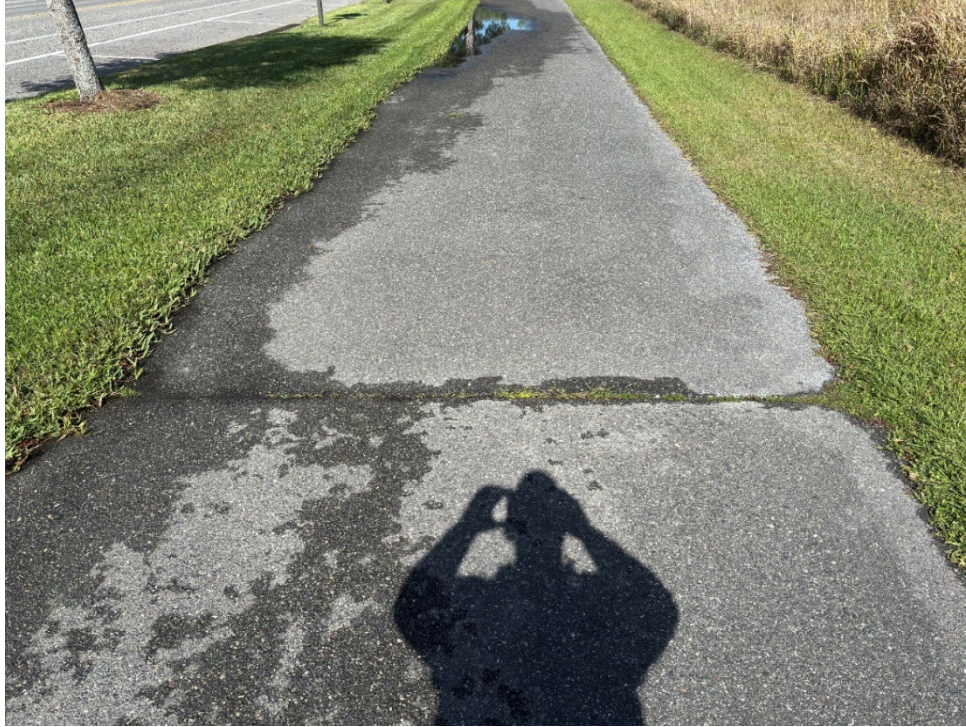
**Photo 33**  
**Cracked Asphalt from Side to Side (Increased Cracking Severity Observed)**  
**(Refer to Prior Photo 43 – 2025 Assessment)**

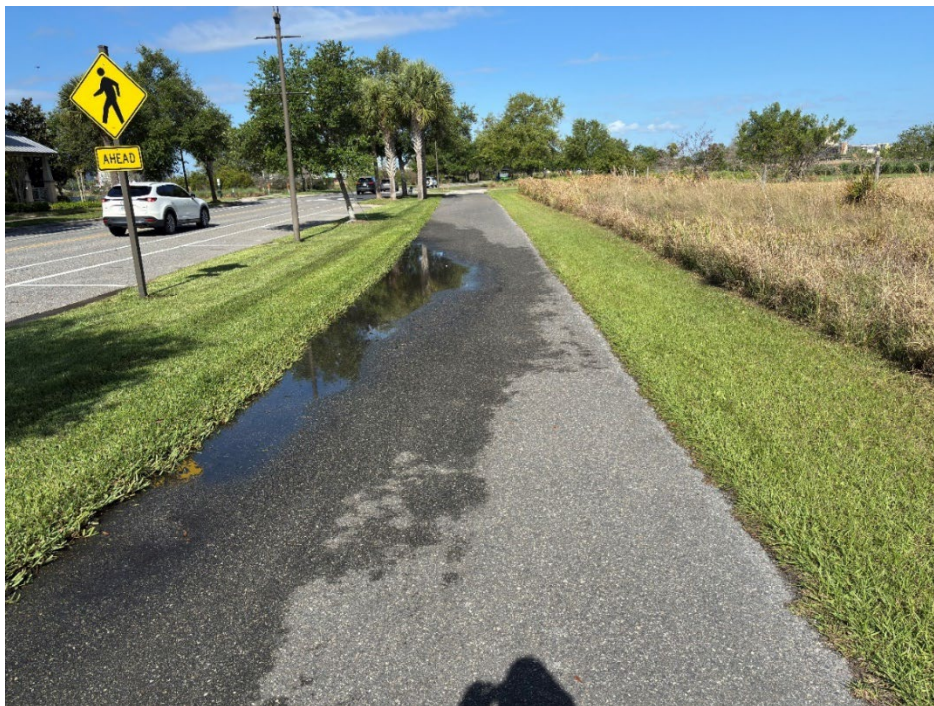
**Photo 33.1 – Water Ponding**  
**(New Photo – 2026 Assessment)**

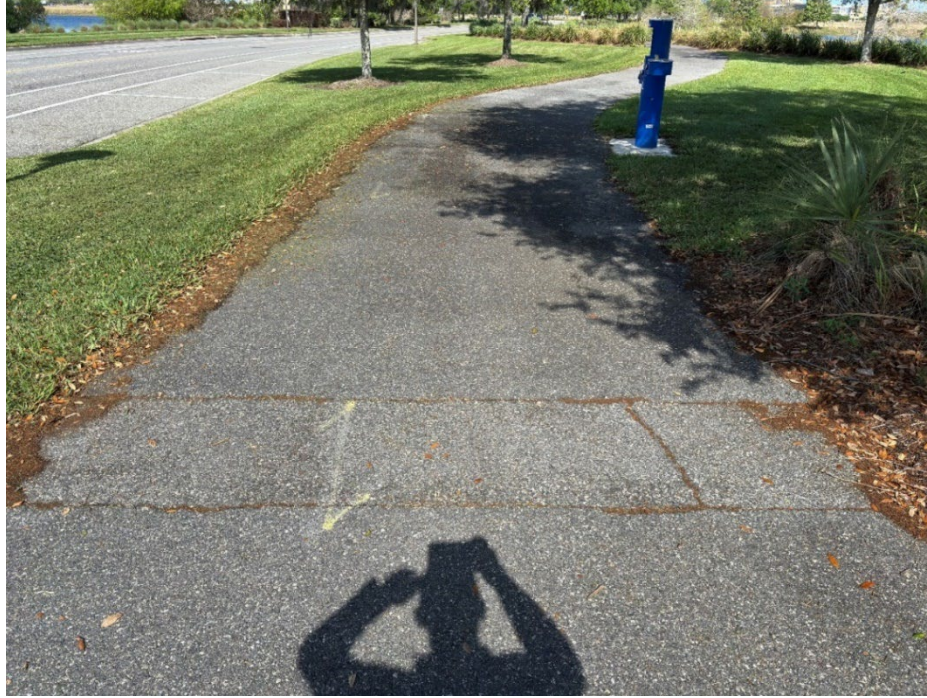
**Photo 33.2 - Multiple Cracked Asphalt and Asphalt Raveling  
(New Photo – 2026 Assessment)**

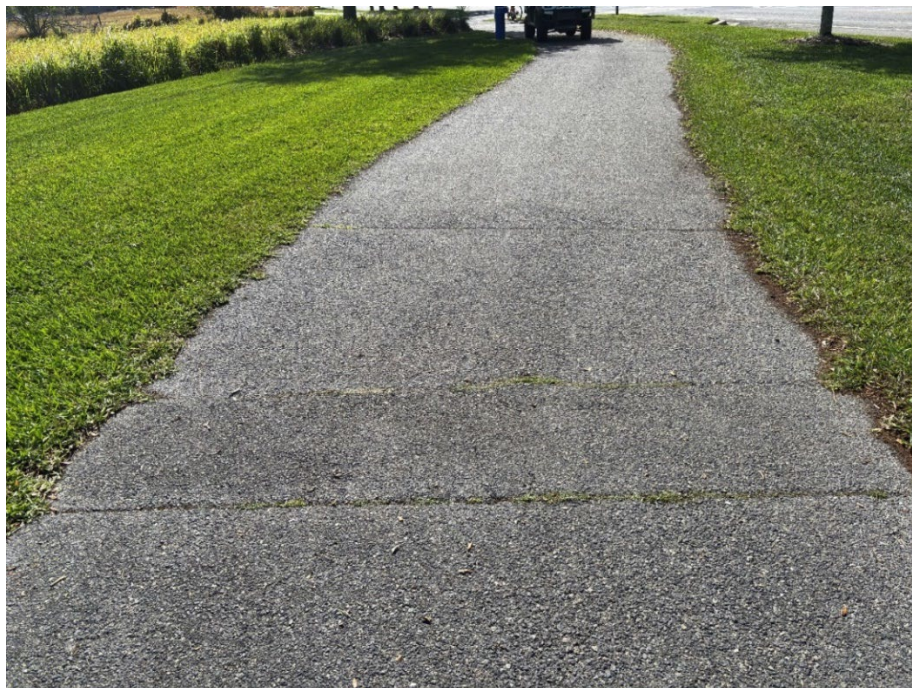
**Photo 34 - Cracked Asphalt and Asphalt Raveling (No Observed Changes)  
(Refer to Prior Photo 47 – 2025 Assessment)**

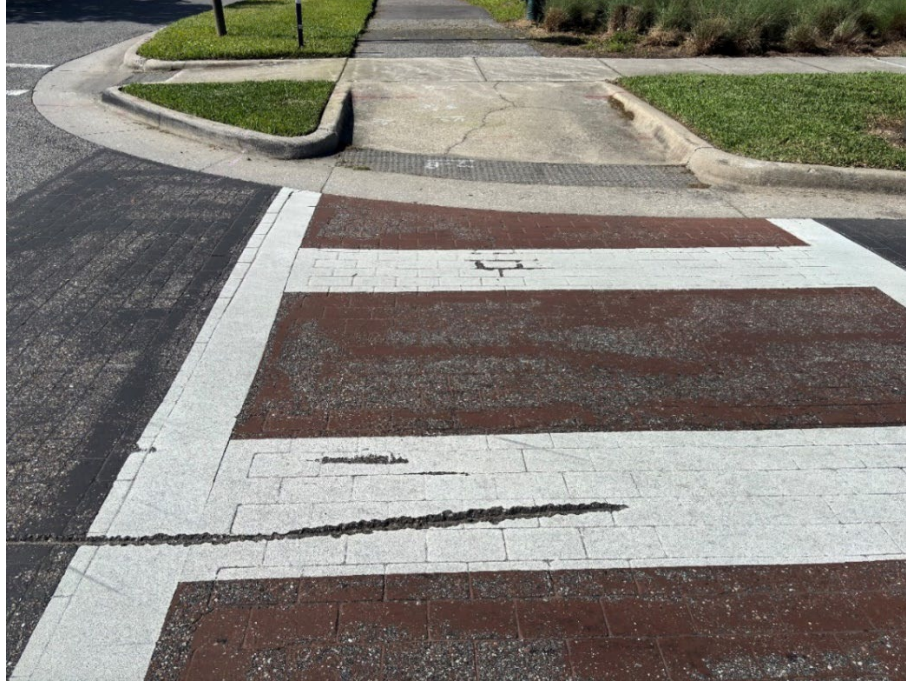
**Photo 35**  
**Deteriorating Thermoplastic and Worn Crosswalk Coloration (No Observed Changes)**  
**(Refer to Prior Photo 50 – 2025 Assessment)**

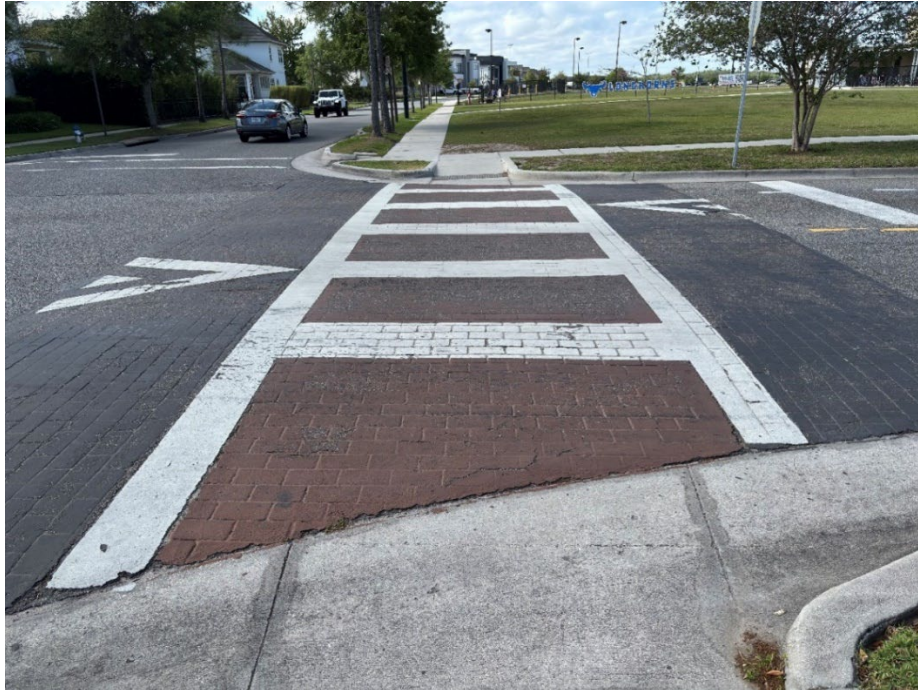
**Photo 36**  
**Deteriorating Thermoplastic and Worn Crosswalk Coloration (No Observed Changes)**  
**(Refer to Prior Photo 51 – 2025 Assessment)**

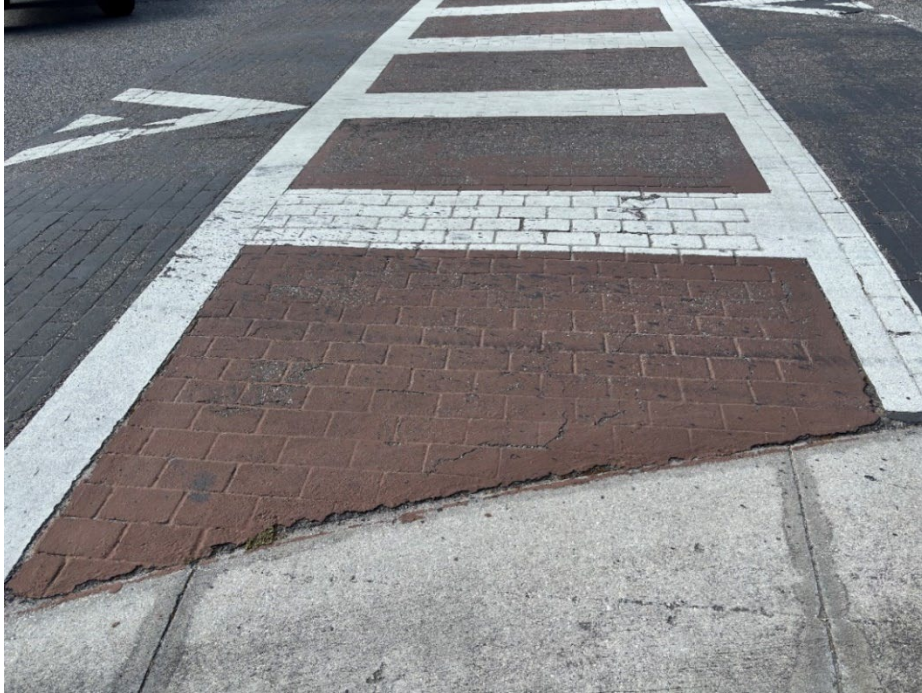
**Photo 37**  
**Deteriorating Thermoplastic and Worn Crosswalk Coloration (No Observed Changes)**  
**(Refer to Prior Photo 52 – 2025 Assessment)**

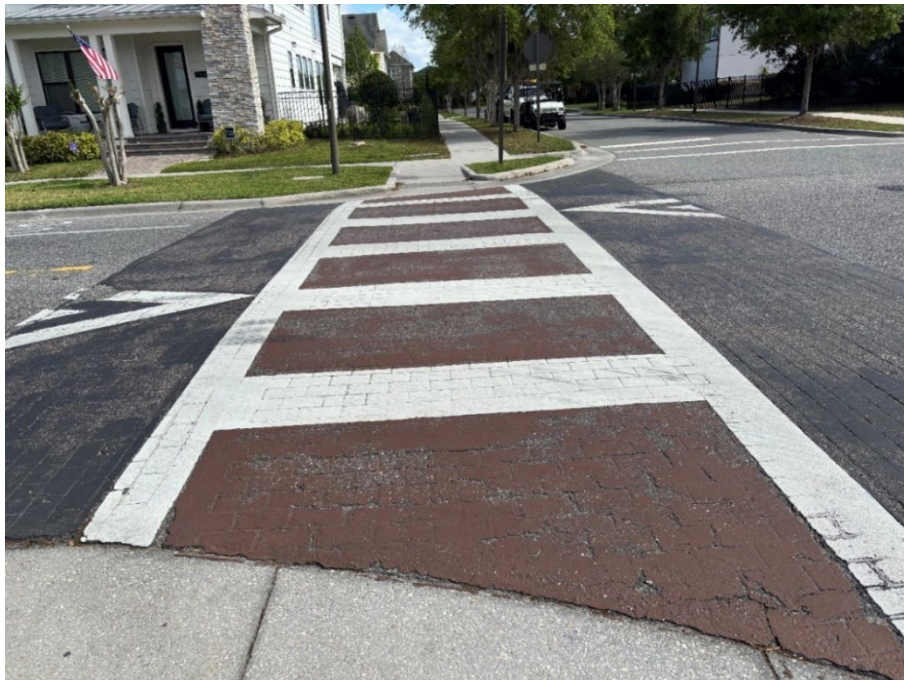
**Photo 38**  
**Deteriorating Thermoplastic and Worn Crosswalk Coloration (No Observed Changes)**  
**(Refer to Prior Photo 53 – 2025 Assessment)**

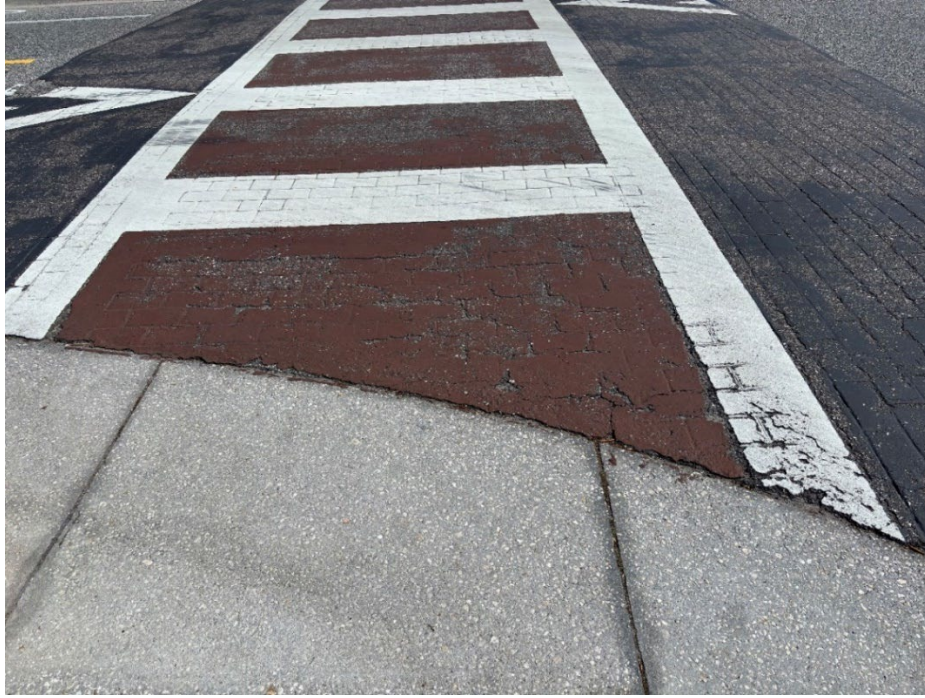
**Photo 39**  
**Deteriorating Thermoplastic and Worn Crosswalk Coloration (No Observed Changes)**  
**(Refer to Prior Photo 54 – 2025 Assessment)**

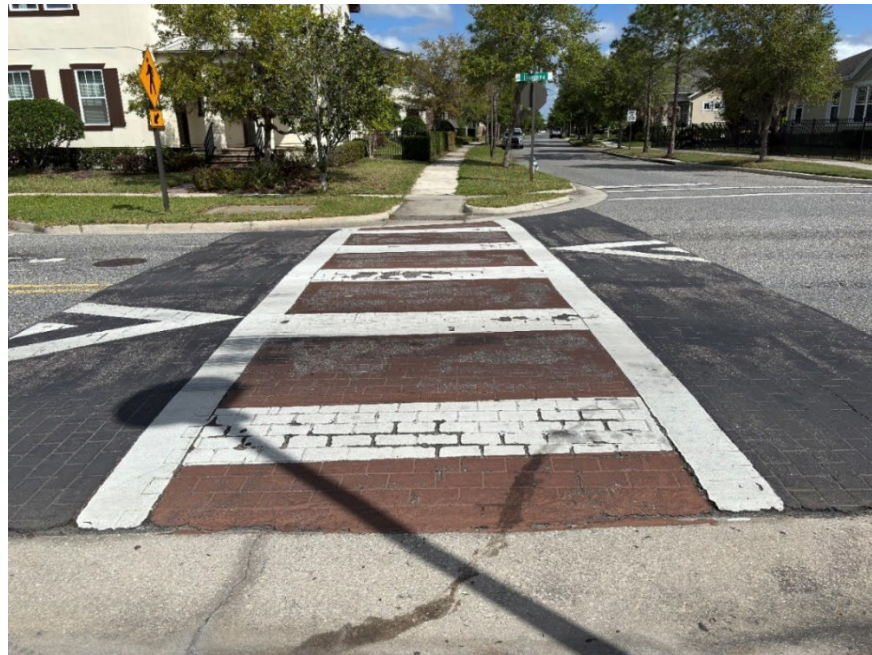
**Photo 40**  
**Deteriorating Thermoplastic and Worn Crosswalk Coloration**  
**(Further Deterioration Observed)**  
**(Refer to Prior Photo 55 – 2025 Assessment)**

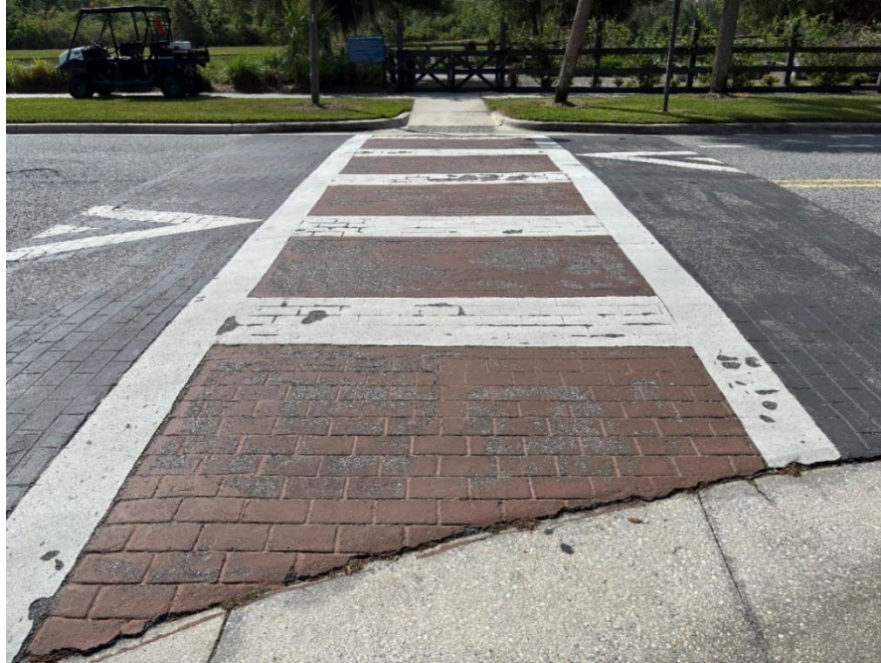
**Photo 41**  
**Deteriorating Thermoplastic and Worn Crosswalk Coloration**  
**(Further Deterioration Observed)**  
**(Refer to Prior Photo 56 – 2025 Assessment)**

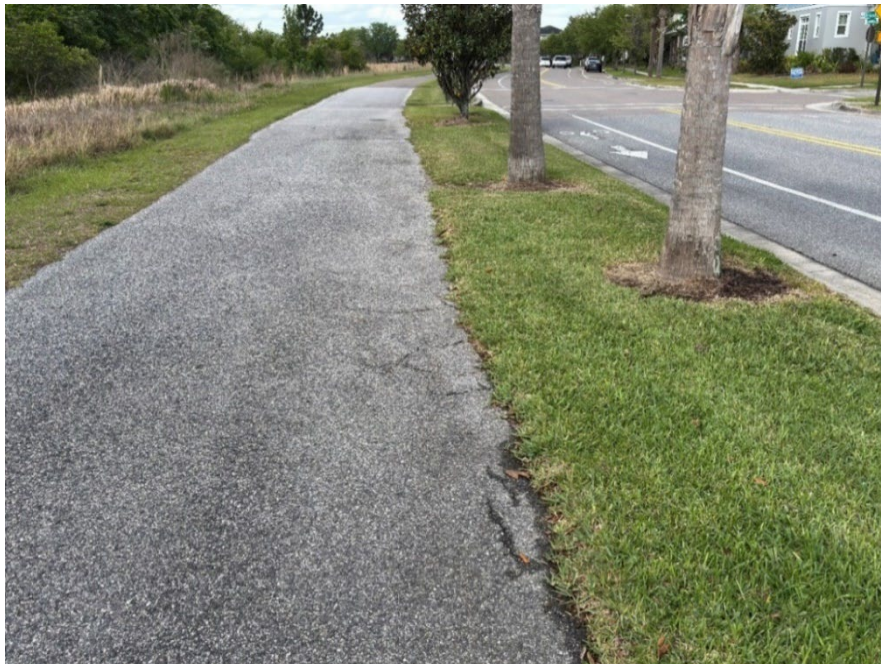
**Photo 42**  
**Asphalt Raveling and Base Failure (Further Edge Failure Observed)**  
**(Refer to Prior Photo 57 – 2025 Assessment)**

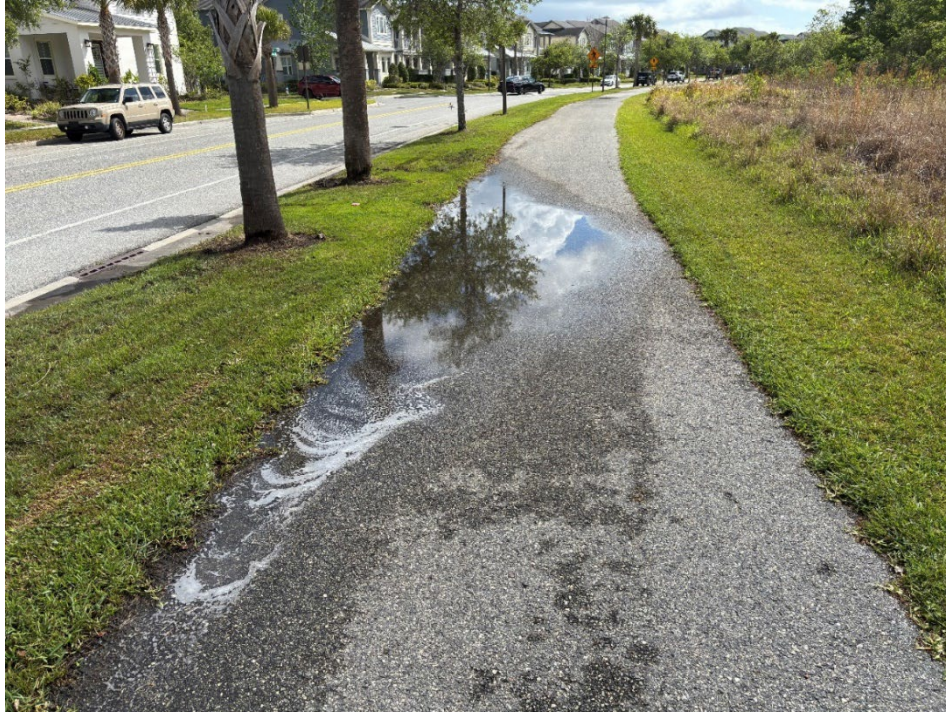
**Photo 42.1 – Water Ponding  
(New Photo – 2026 Assessment)**

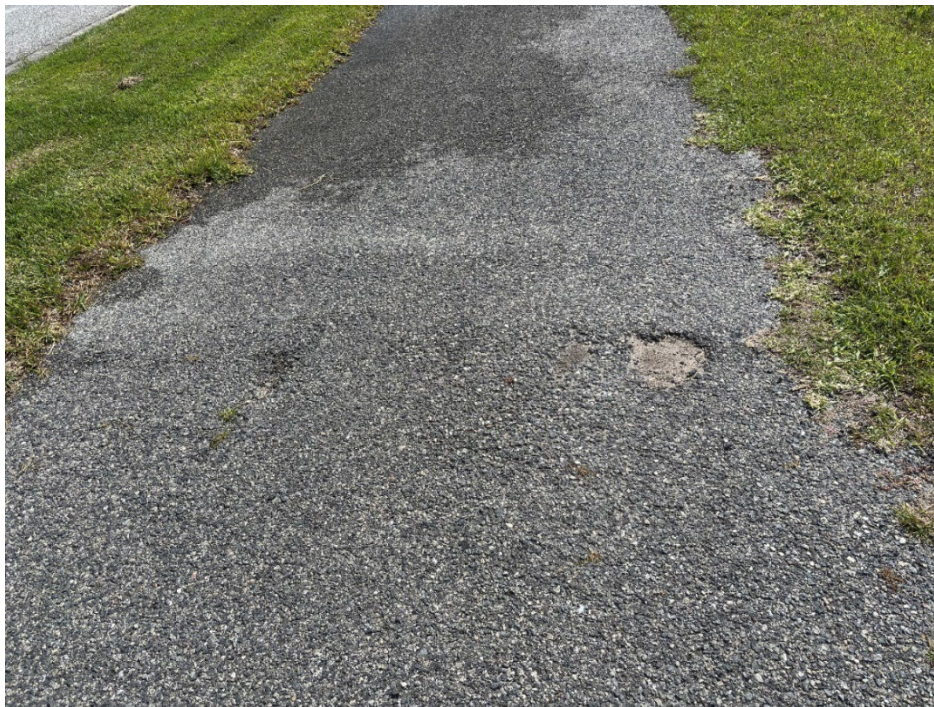
**Photo 42.2 – Asphalt Spalling  
(New Photo – 2026 Assessment)**

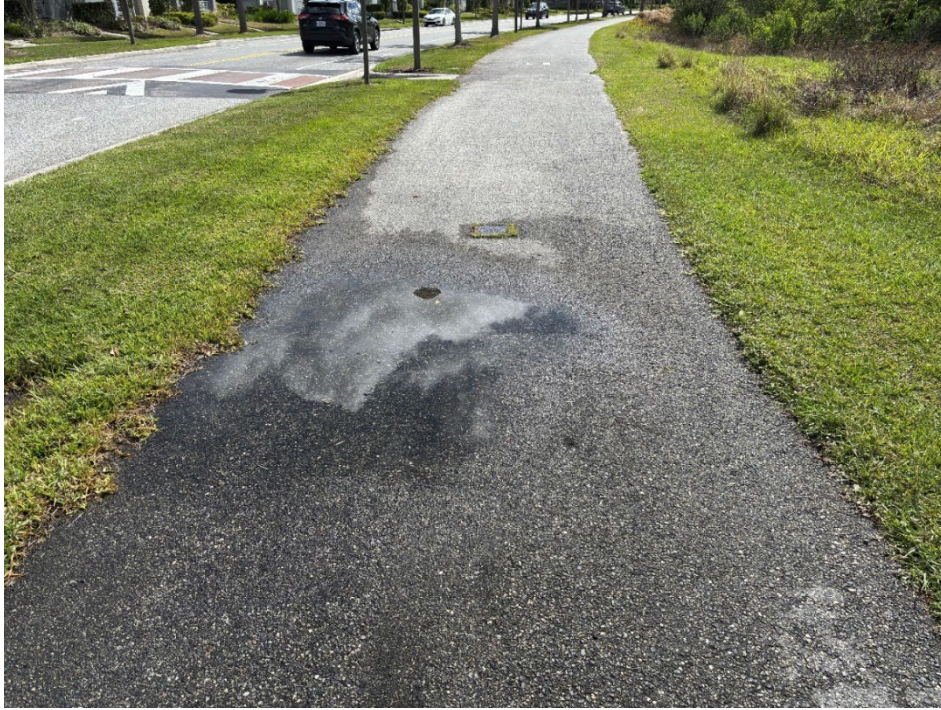
**Photo 42.3 – Water Ponding  
(New Photo – 2026 Assessment)**

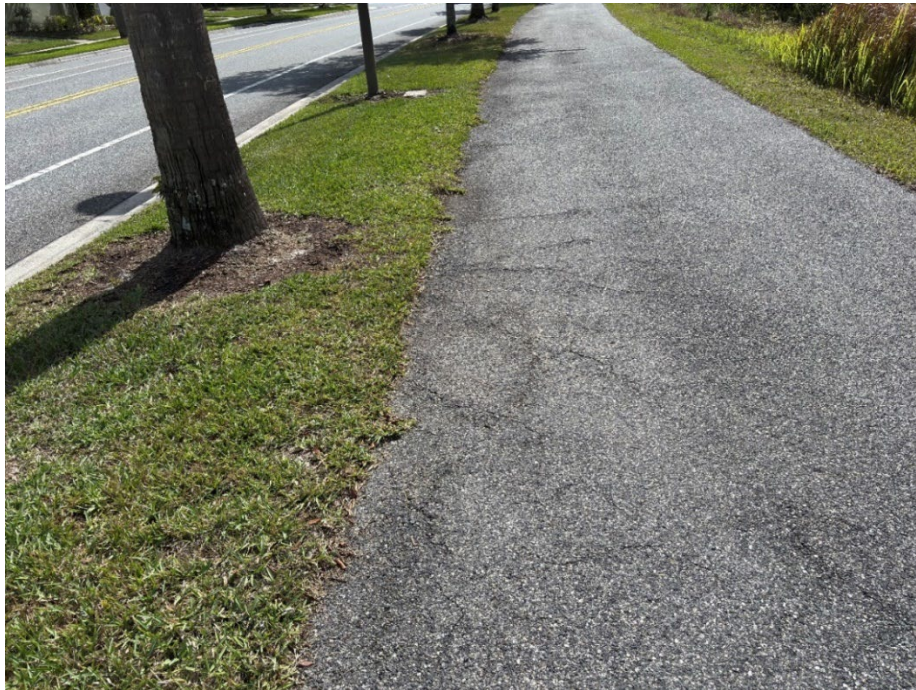
**Photo 43 - Asphalt Raveling and Base Failure (No Observed Changes)  
(Refer to Prior Photo 58 – 2025 Assessment)**

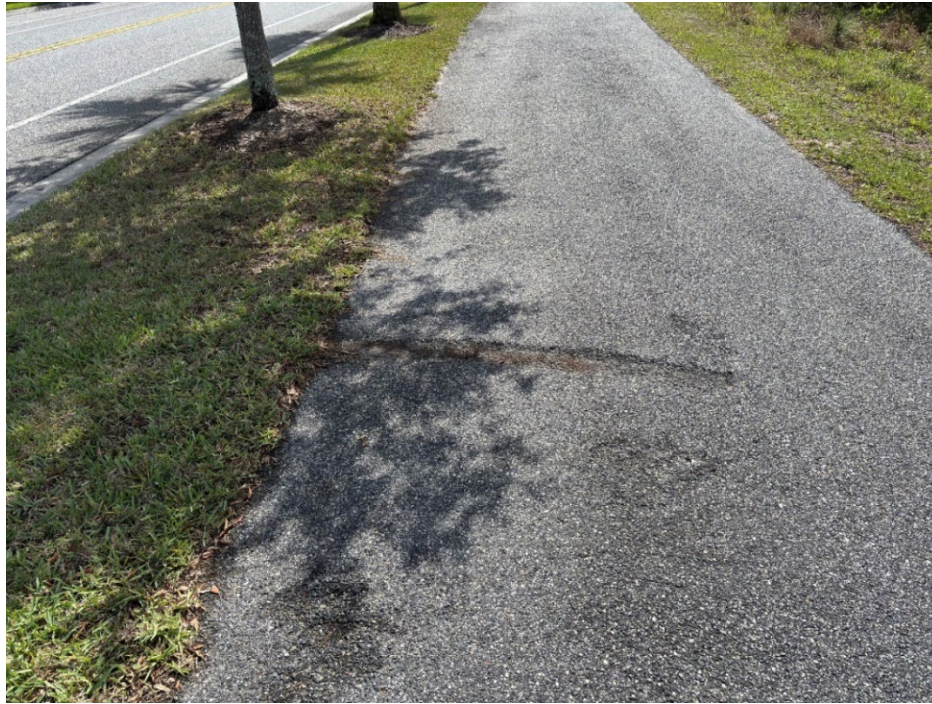
**Photo 44 - Damage and Uneven Asphalt (No Observed Changes)  
(Refer to Prior Photo 59 – 2025 Assessment)**

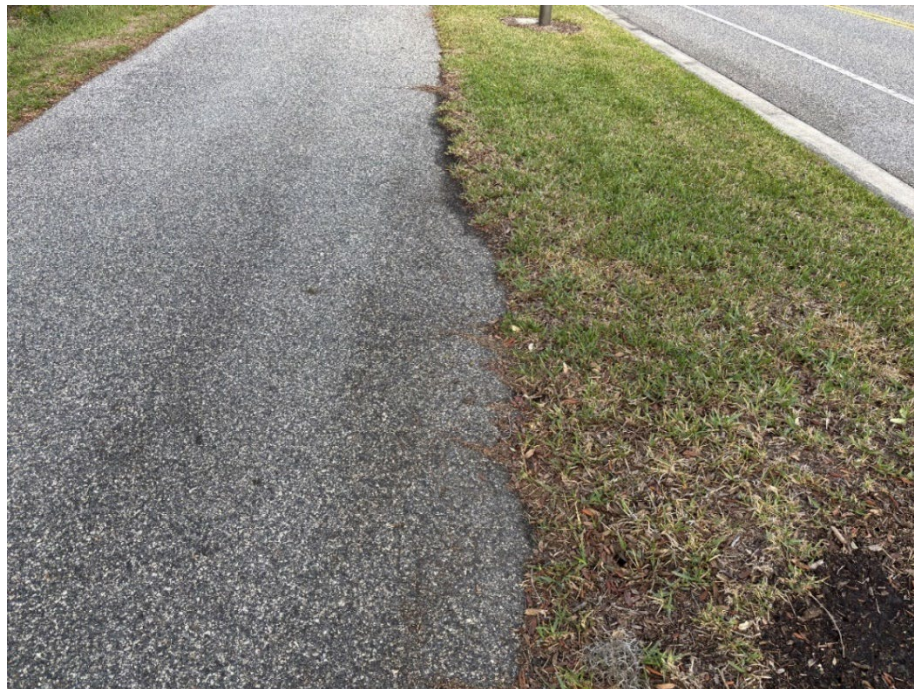
**Photo 45  
Asphalt Pavement Edge Failure (No Observed Changes)  
(Refer to Prior Photo 60 – 2025 Assessment)**

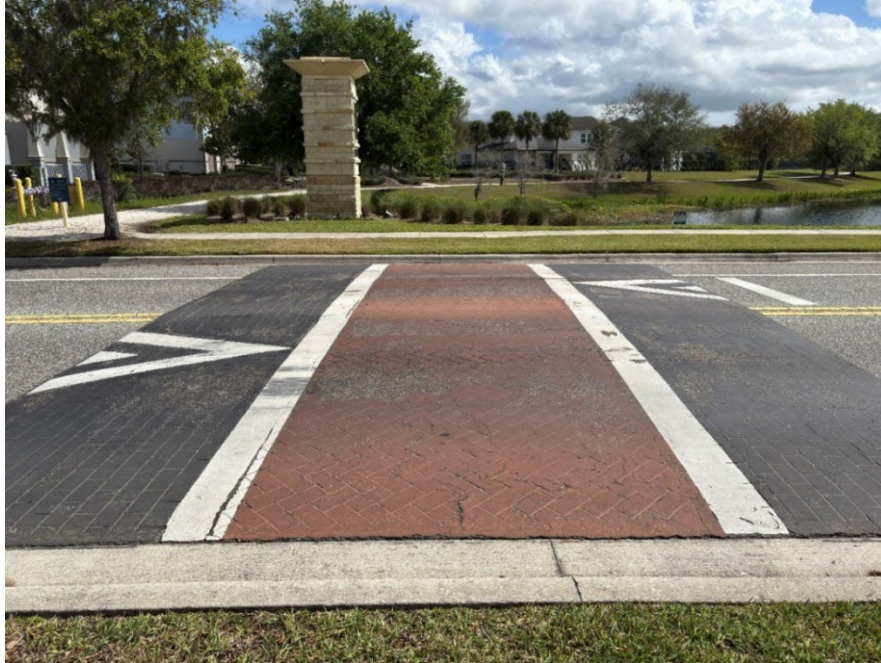
**Photo 45.1**  
**Deteriorating Thermoplastic, Worn Crosswalk Coloration, and Asphalt Deformation**  
**(New Photo – 2026 Assessment)**

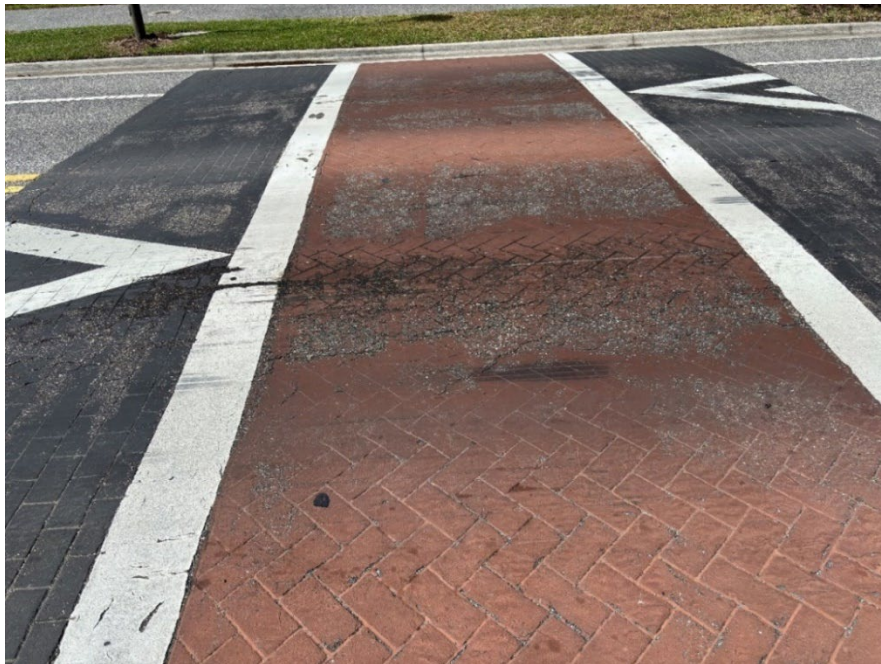
**Photo 46**  
**Deteriorating Thermoplastic, Worn Crosswalk Coloration, and Asphalt Deformation**  
**(Further Deterioration Observed)**  
**(Refer to Prior Photo 62 – 2025 Assessment)**

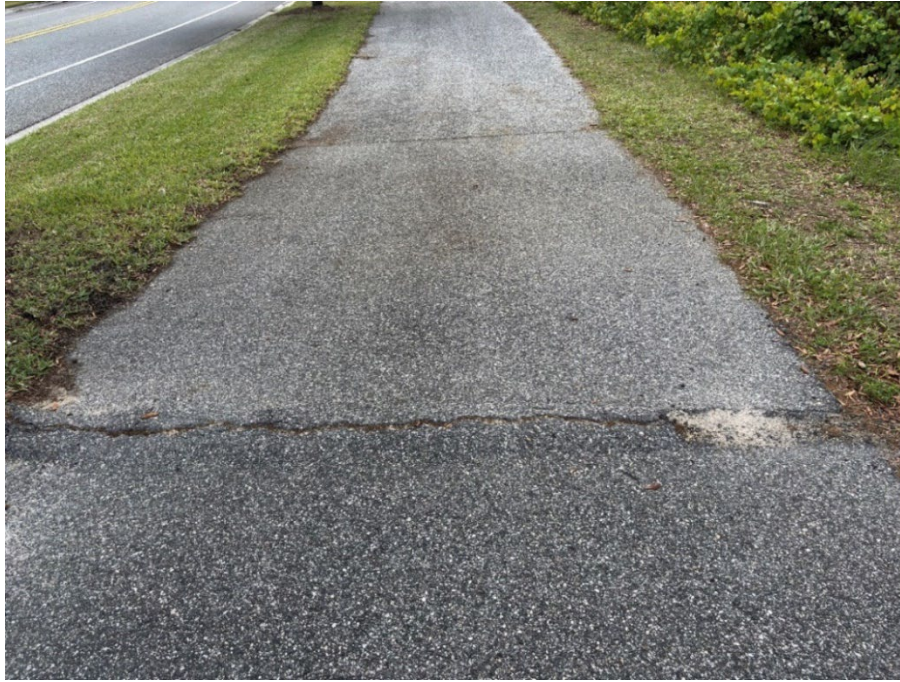
**Photo 47**  
**Asphalt Patch Lifting (Cracked Asphalt from Side to Side Observed)**  
**(Refer to Prior Photo 63 – 2025 Assessment)**

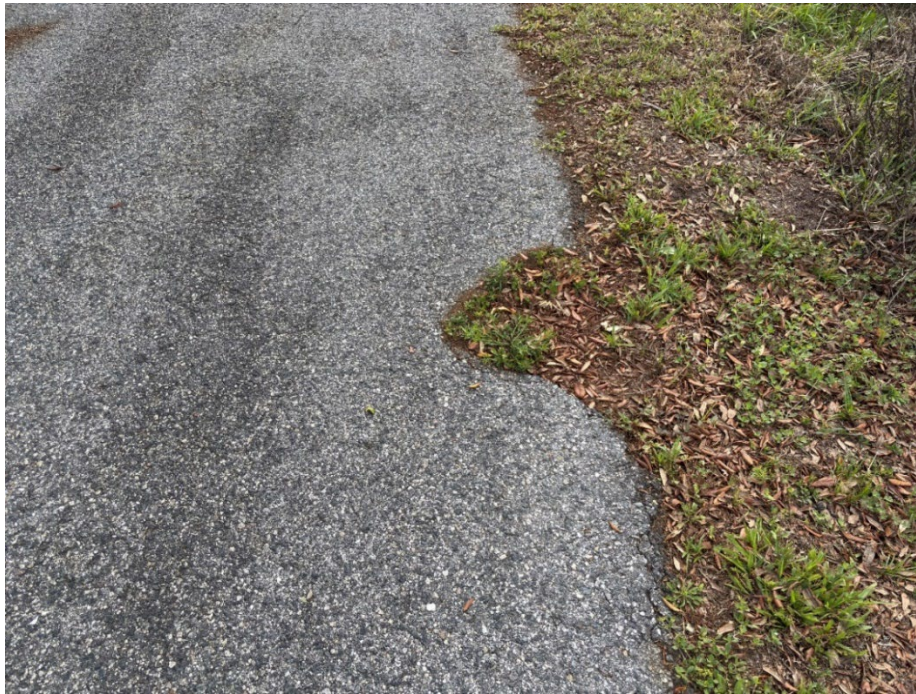
**Photo 48 - Asphalt Edge Failure (No Observed Changes)**  
**(Refer to Prior Photo 66 – 2025 Assessment)**

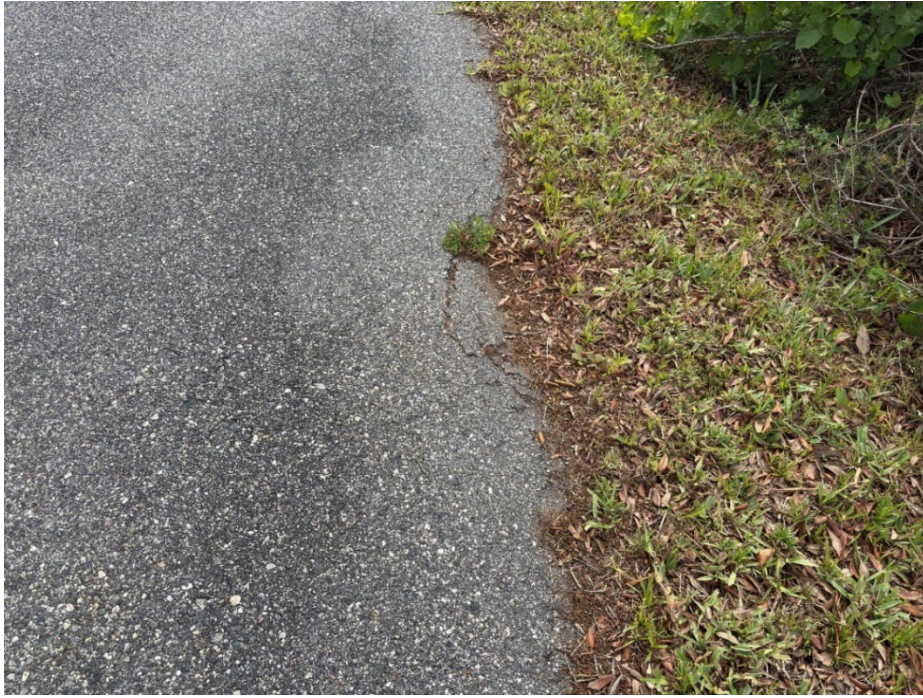
**Photo 49 - Asphalt Edge Failure (No Observed Changes)  
(Refer to Prior Photo 67 – 2025 Assessment)**

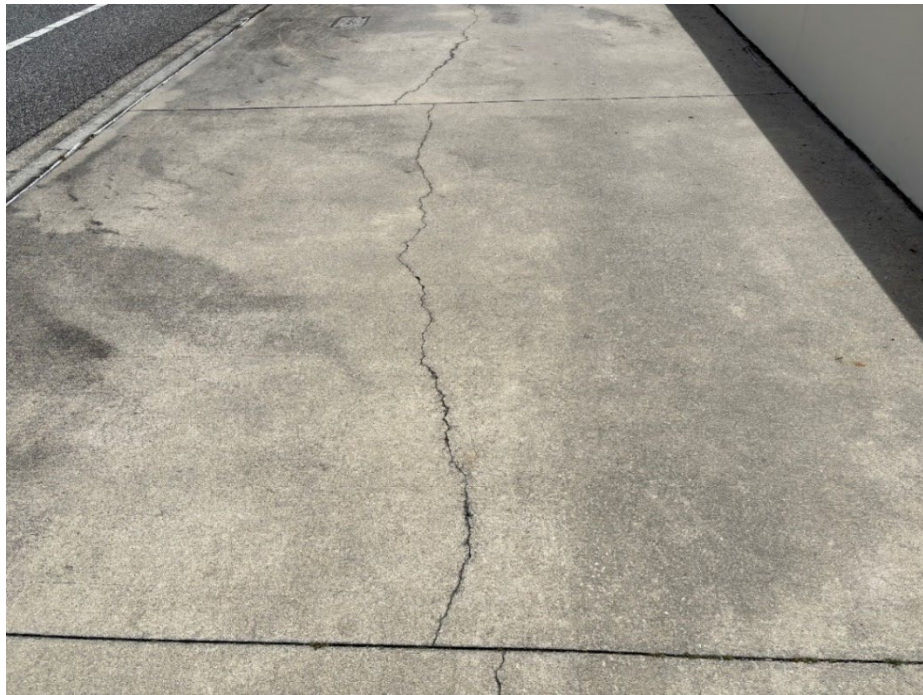
**Photo 51 - Surficial Cracked Concrete (No Observed Changes)  
(Refer to Prior Photo 70 – 2025 Assessment)**

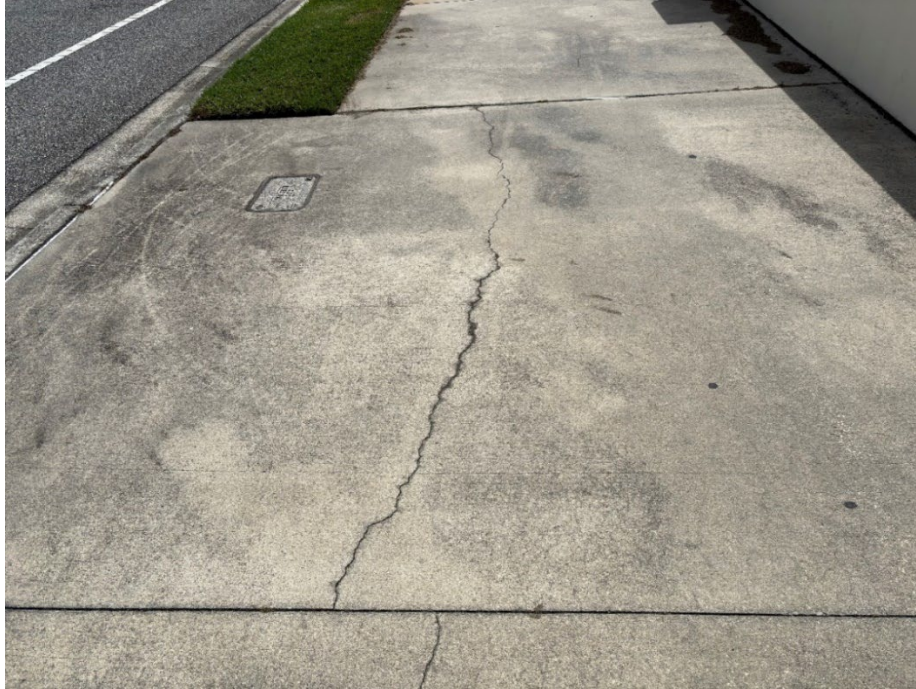
**Photo 51 - Surficial Cracked Concrete (No Observed Changes)  
(Refer to Prior Photo 71 – 2025 Assessment)**

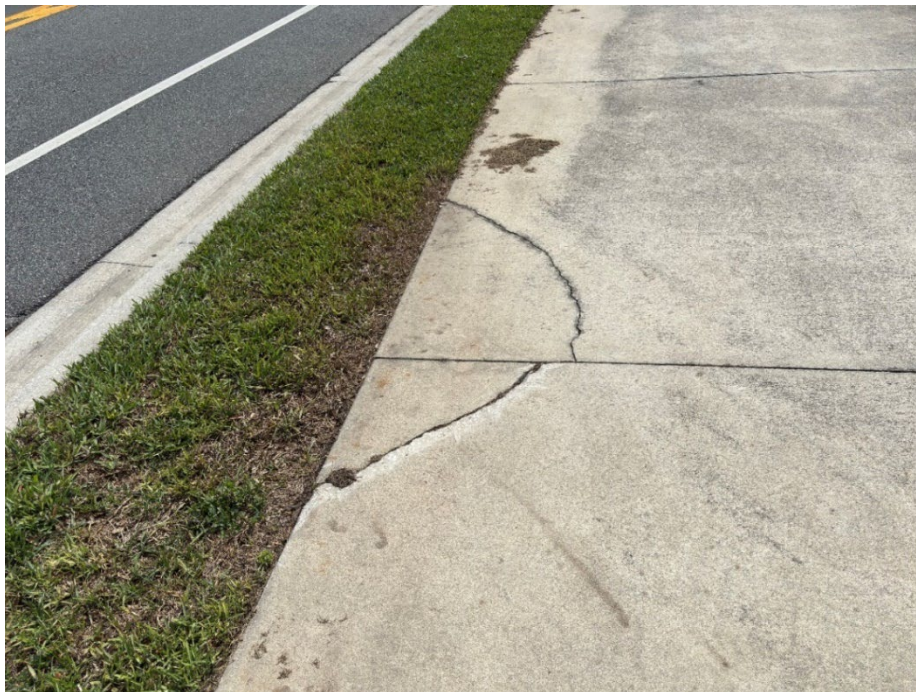
**Photo 52 - Cracked Concrete and Base Failure (No Observed Changes)  
(Refer to Prior Photo 72 – 2025 Assessment)**

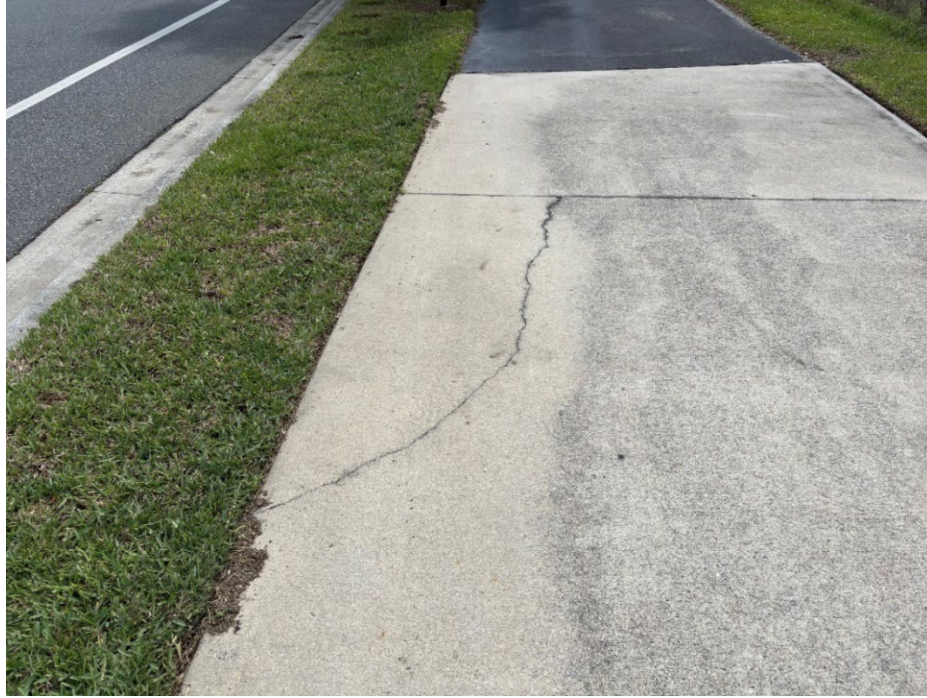
**Photo 53 - Cracked Concrete and Base Failure (No Observed Changes)  
(Refer to Prior Photo 73 – 2025 Assessment)**

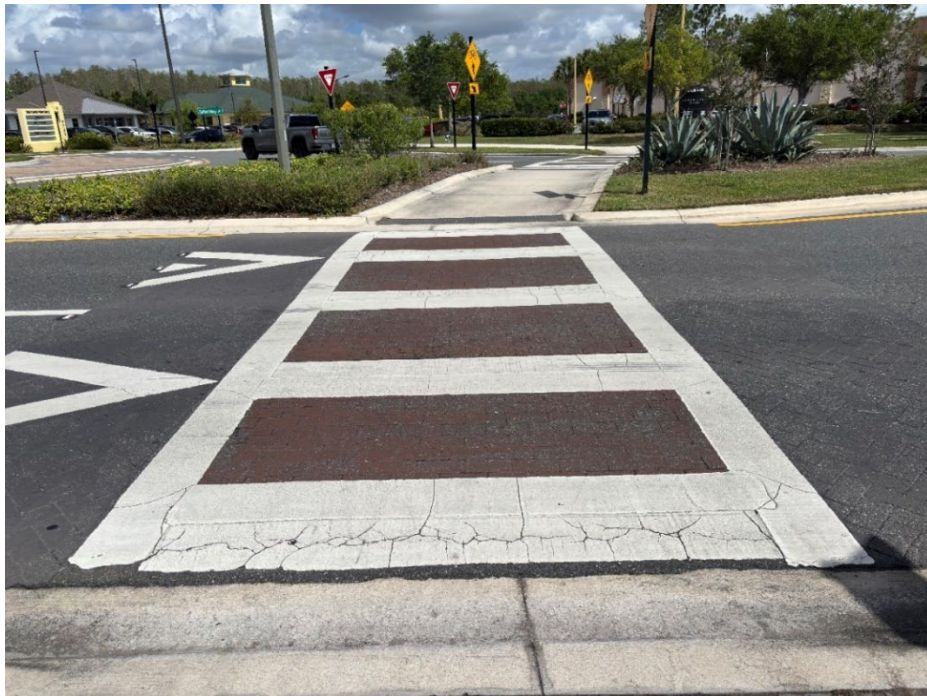
**Photo 54  
Deteriorating Thermoplastic and Worn Crosswalk Coloration (No Observed Changes)  
(Refer to Prior Photo 74 – 2025 Assessment)**

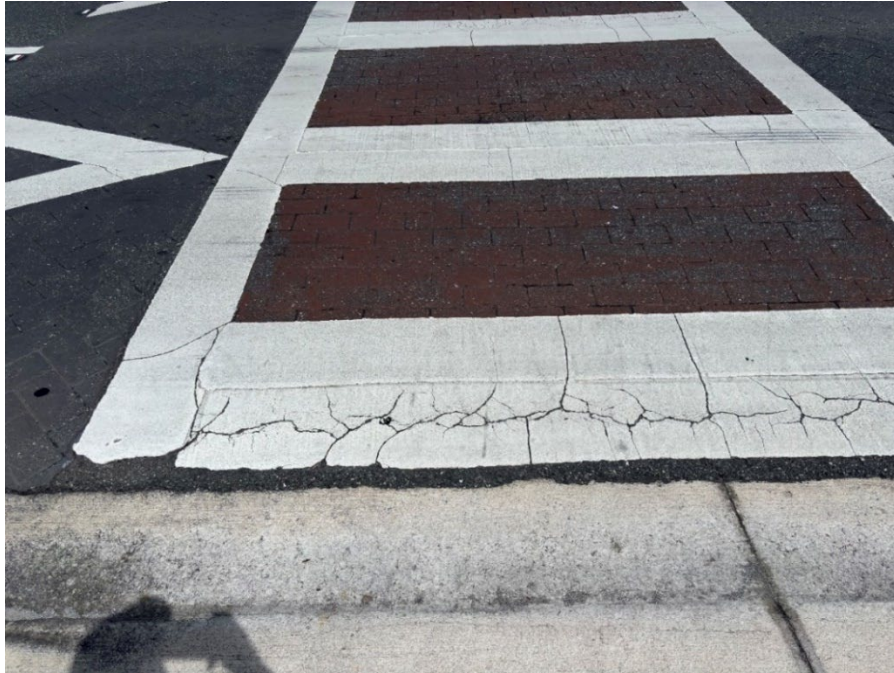
**Photo 55**  
**Deteriorating Thermoplastic and Worn Crosswalk Coloration (No Observed Changes)**  
**(Refer to Prior Photo 75 – 2025 Assessment)**

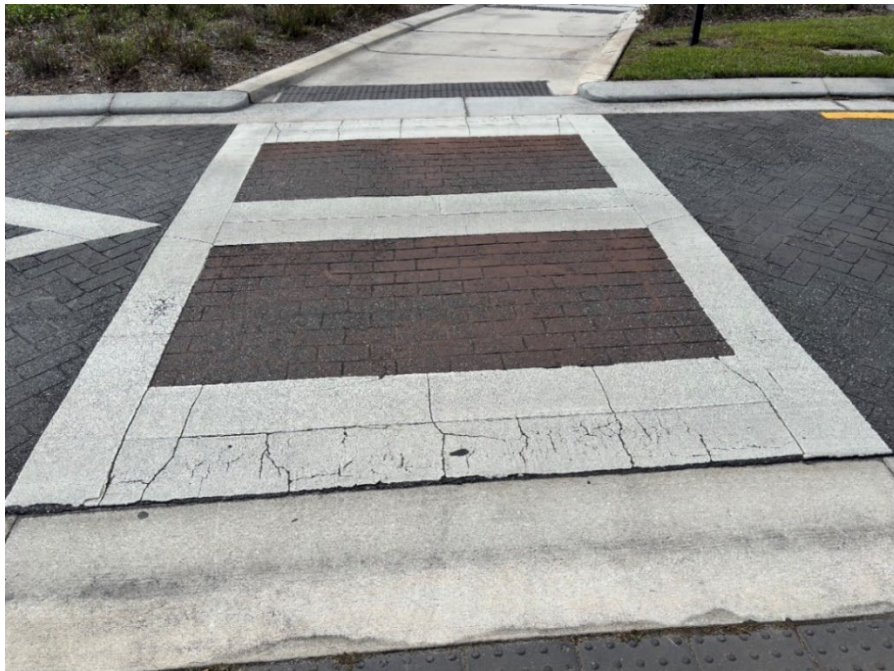
**Photo 56**  
**Deteriorating Thermoplastic and Worn Crosswalk Coloration**  
**(Further Deterioration Observed)**  
**(Refer to Prior Photo 76 – 2025 Assessment)**

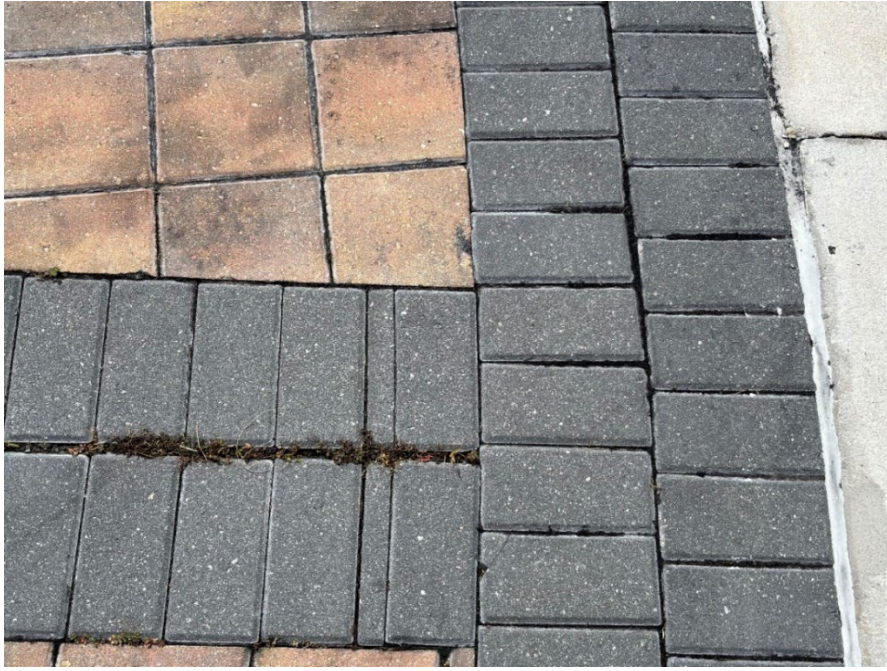
**Photo 57**  
**Broken Concrete Pavers on Truck Apron (No Observed Changes)**  
**(Refer to Prior Photo 77 – 2025 Assessment)**
